Inspection Report

**Schultz Property
Inspection**

Address: 52695 Avenida Bermudas, La
Quinta, CA 92253

Inspector: Bill Schultz
P.O. Box 3222
Cathedral City, CA 92235
(760) 904-4798
8/30/2023

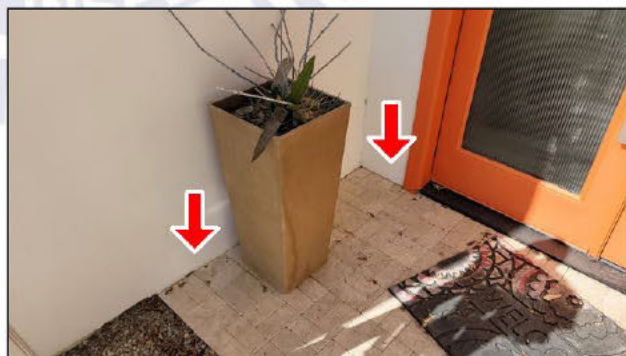
1.0 Item 1(Picture) Weep screed

🔧 (1) It should be noted that the stucco weep screed is covered at the exterior in areas and may not allow drainage of the wall cavity. Landscaping and slabs should be 2 to 6 inches below level of weep screed. We are unable to determine if there are any moisture problems in the wall at these areas. If these are areas of concern for buyer, we recommend further evaluation by proper specialist.

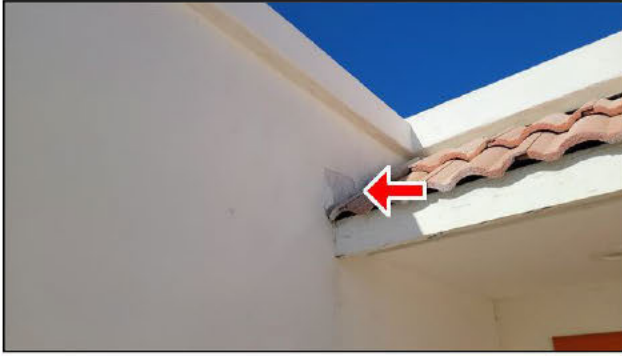
1.0 Item 3(Picture)

🔧 (2) The Stucco coating at the exterior in areas is peeling paint or failing. This is a maintenance issue. I recommend prep and paint using a qualified contractor.

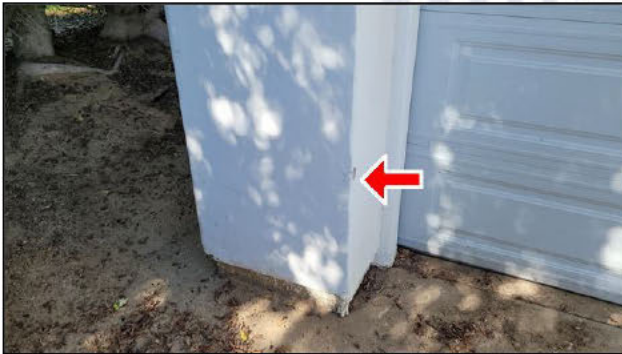
1.0 Item 5(Picture)

🔧 (3) The Stucco coating at the exterior is damaged. Deterioration can eventually occur if not corrected. A qualified person should repair or replace as needed.

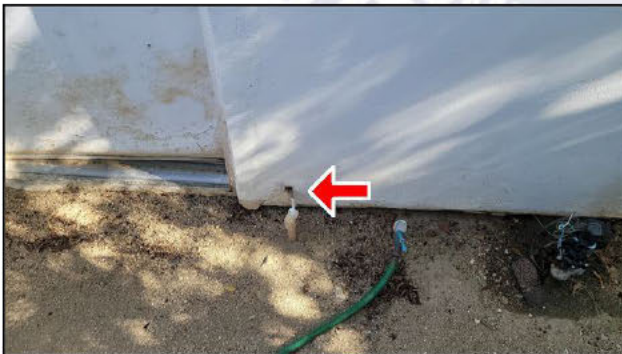
1.0 Item 7(Picture)

🔧 (4) The Stucco coating at the exterior in areas has holes and protrusions that need to be sealed properly. Moisture intrusion may occur if not corrected. A qualified person should repair or replace as needed.

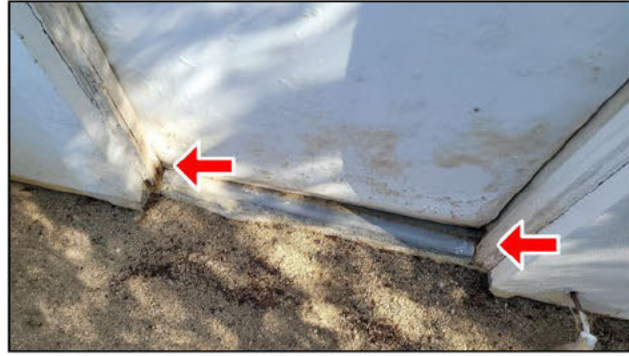
1.0 Item 9(Picture)

🐿 (5) The Wood trim at the exterior in areas is peeling paint or failing. This is a maintenance issue. I recommend prep, prime and paint as needed.

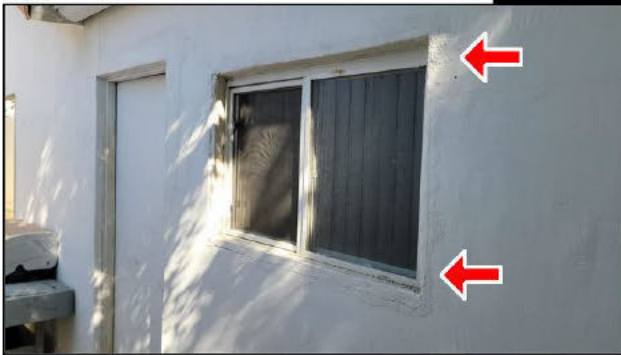
1.0 Item 10(Picture)

🐿 (6) The Stucco coating at the left side (facing front) and rear of home shows signs of repair. We are unable to determine if items are flashed properly. A qualified contractor should inspect further and correct as needed.

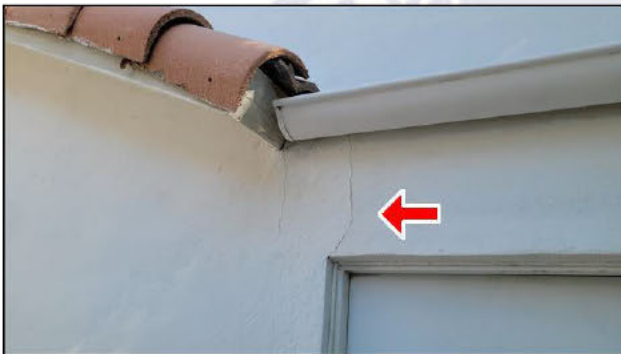
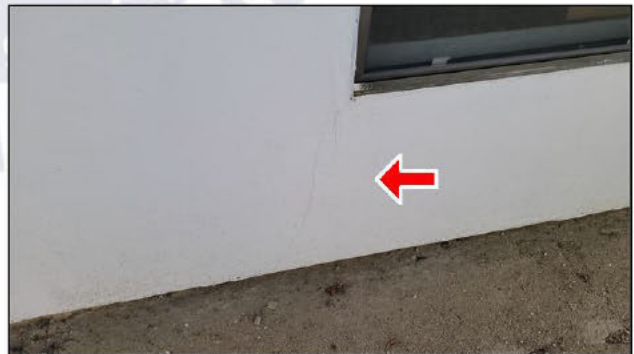
1.0 Item 12(Picture)

🐿 (7) Stucco coating at various areas of exterior is cracked. Cracks are fairly common in stucco. Various stucco associations recommend cracks wider than one-sixteenth of an inch should be sealed. Recommend sealing of cracks to prevent moisture intrusion and further deterioration. If cracks are of concern to buyer, recommend further evaluation by proper specialist be completed.

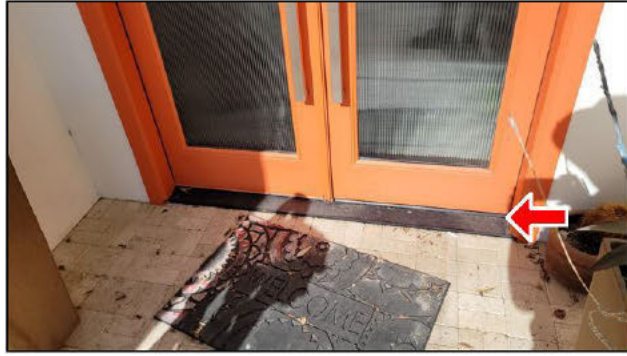
1.1 Item 1(Picture)

🐿 (1) The main entry door (s) are not installed above grade. This may allow moisture intrusion and debris entry. I recommend correct as necessary.

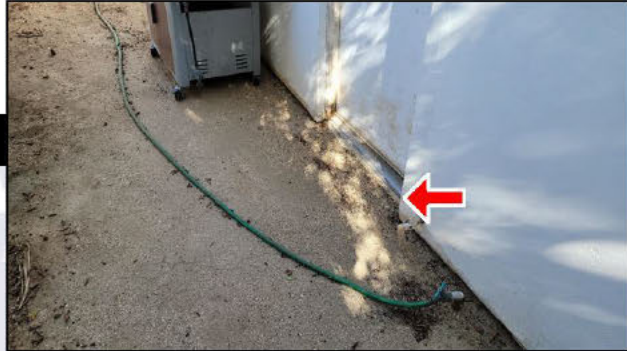
1.1 Item 2(Picture)

🐿 (2) The garage side entry door is missing a stoop (landing). This is a requirement. A repair or replacement is needed. I recommend correct as necessary.

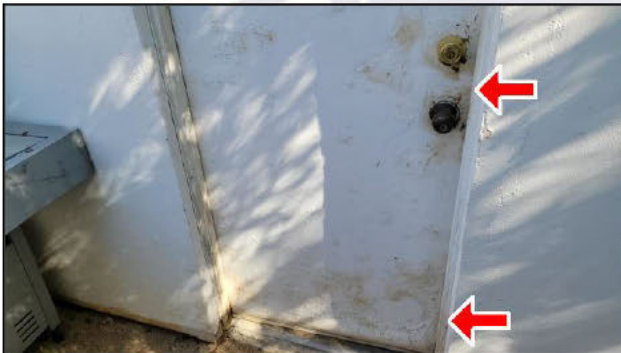
1.1 Item 3(Picture)

🐿 (3) The garage entry door is damaged from moisture. A repair or replacement is needed. A qualified person should repair or replace as needed.

The garage side entry door does not latch. An adjustment/repair is needed. I recommend correct as necessary.

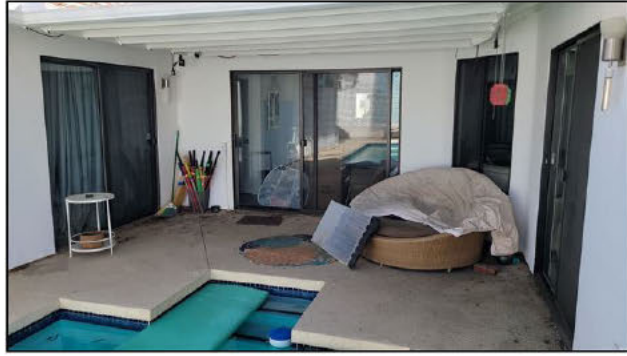
1.1 Item 5(Picture)

🐿 (4) Sliding glass doors at all locations have sliding glass door section installed on the exterior. When the sliding door section is installed in this orientation it may allow door to be removed easier by lifting door out of track and compromise security. We are unable to determine if doors were installed in the proper orientation. Sometimes auxiliary lock sets can be installed to lock doors more securely. If this is a concern, we recommend further evaluation by proper licensed specialist.

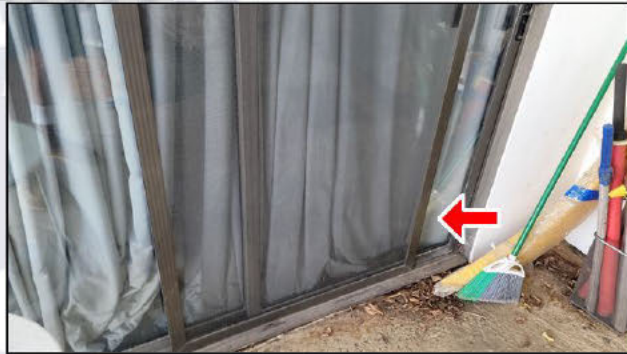
1.1 Item 6(Picture)

🐿 (5) Sliding screen for glass door unit (s) at Primary bedroom does not travel across tracks properly. This is a maintenance issue and is for your information. I recommend correct as necessary.

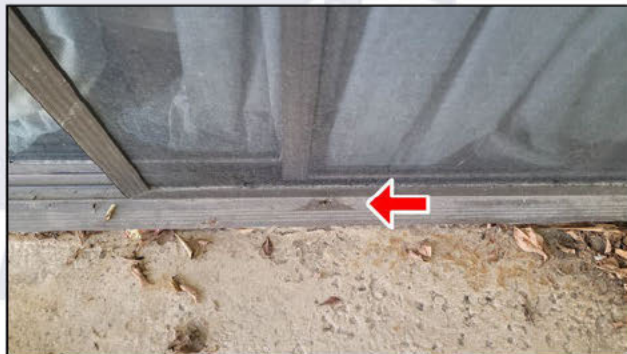
1.1 Item 7(Picture)

🐿 (6) Sliding glass door track (s) at rear of home are damaged. This is a maintenance issue and is for your information. I recommend correct as necessary.

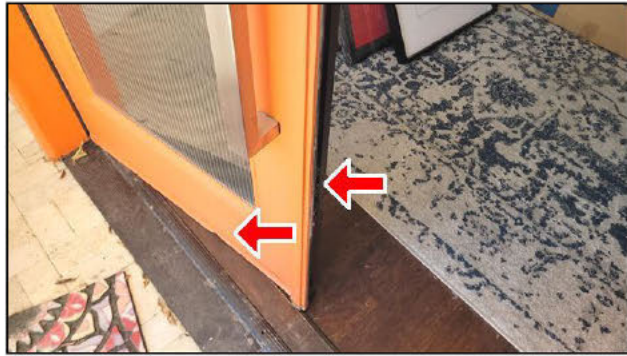
1.1 Item 8(Picture)

🔧 (7) The main entry door (s) needs weather-stripping repaired or replaced. This is a maintenance issue and is for your information. I recommend correct as necessary.

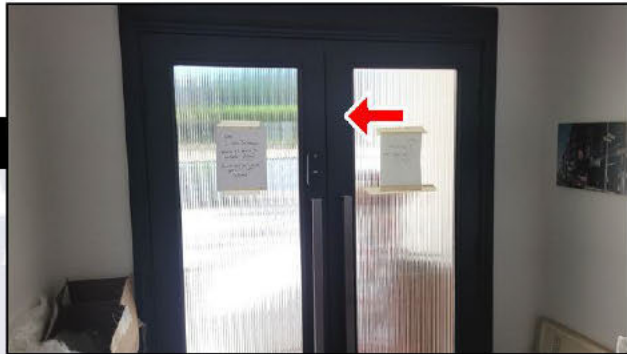
1.1 Item 9(Picture)

🔧 (8) The main entry door (s) rubs at jamb when closing. An adjustment/repair is needed. I recommend correct as necessary.

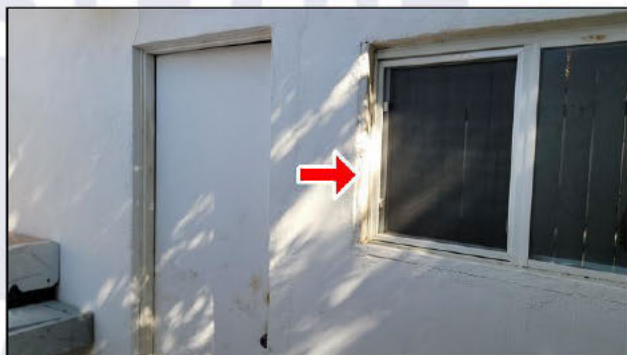
1.2 Item 1(Picture)

🔧 🇨🇦 Glass panes within 24 inches of door swing are not marked as tempered glass at left side (facing front). We are unable to verify if glass panes are tempered. While this may not have been required when this home was constructed, we recommend upgrading for safety.

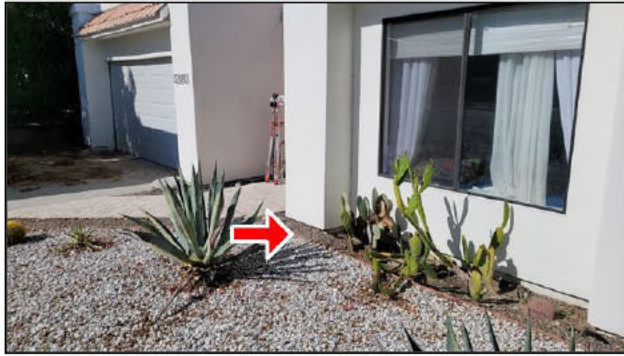
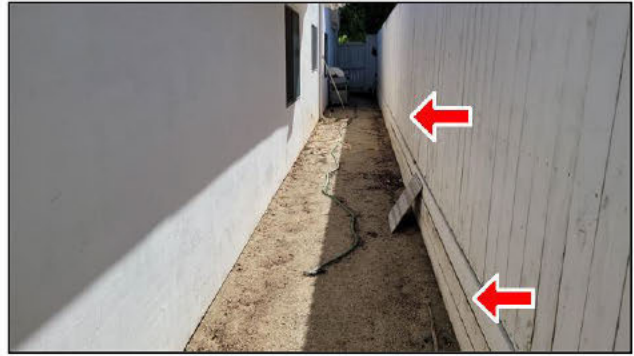
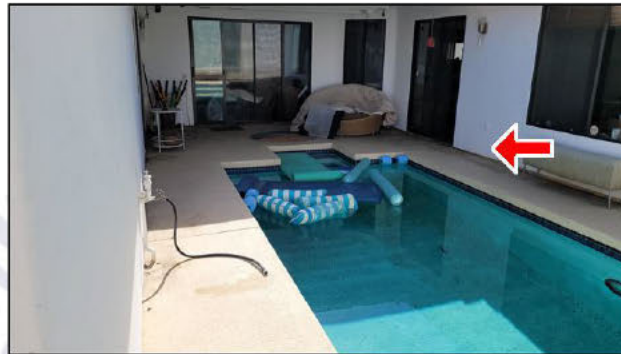
1.4 Item 1(Picture)

or puddles after heavy rain. I am unable to determine due to no rain during inspection period. Recommend correct as necessary.

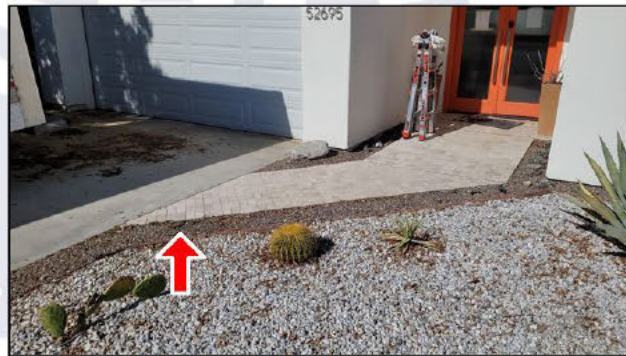
1.4 Item 4(Picture)

🚧 (2) The brick walkway at the front of home is uneven, and can be a tripping hazard. A fall or injury can occur if not corrected. I recommend correct as necessary.

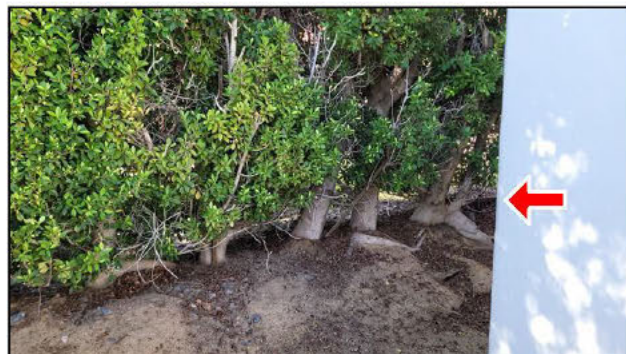
1.4 Item 5(Picture)

🌳 (3) Trees and vegetation planted next to home may cause foundation, plumbing, and/or structural problems if not removed from home. I am unable to determine if any issues exist. Recommend proper specialist evaluate further and correct as necessary to avoid any issues.

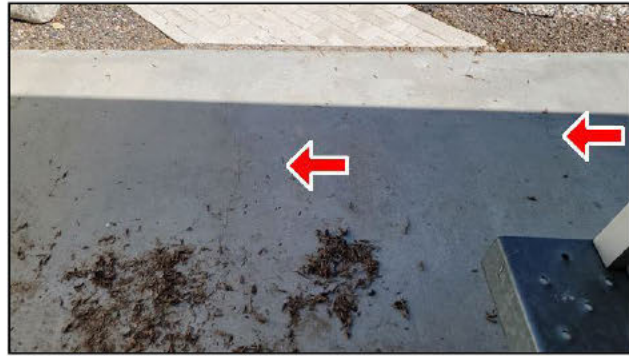
1.4 Item 6(Picture)

👉 (4) The concrete drive at the front of home has hairline cracks (typical). We are unable to determine if this situation will worsen over time. I recommend correct as necessary.

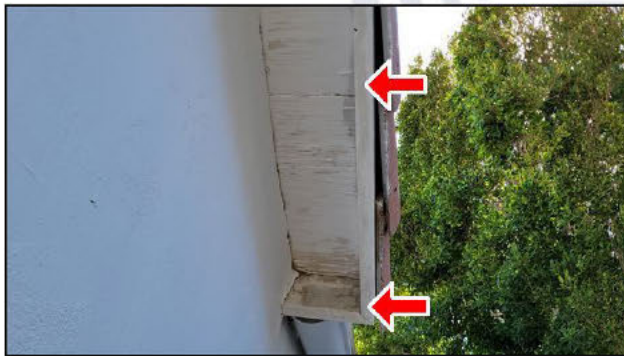
1.5 Item 1(Picture)

👉 (1) Staining noted on wood fascia at front, rear and sides of home indicate moisture could possibly be penetrating the Tile roof at [REDACTED] underlayment down to eaves. Recommend further evaluation by a licensed roofing contractor.

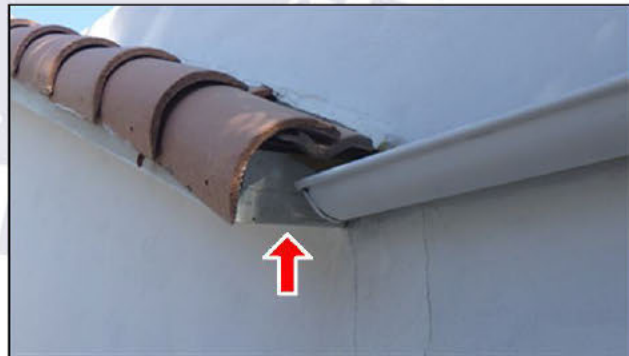
1.5 Item 3(Picture)

👉 (2) The paint on eave is failing. I recommend prep and paint at the left side (facing front) and front of home.

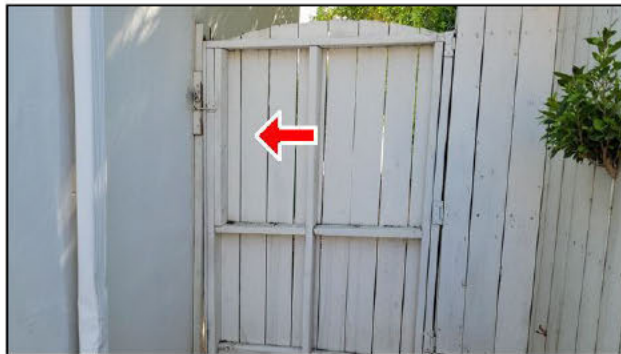
1.6 Item 1(Picture)

🔧 (1) Gate(s) rubs at jamb when closing and does not latch at left side of home (facing front). I recommend repair as needed.

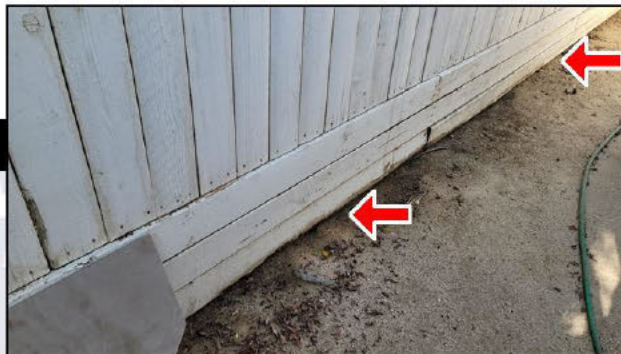
1.6 Item 2(Picture)

🔧 (2) Wood retaining wall at left side of home (facing front) is deteriorated, and improper for retaining soil. A qualified contractor should inspect further and correct as needed.

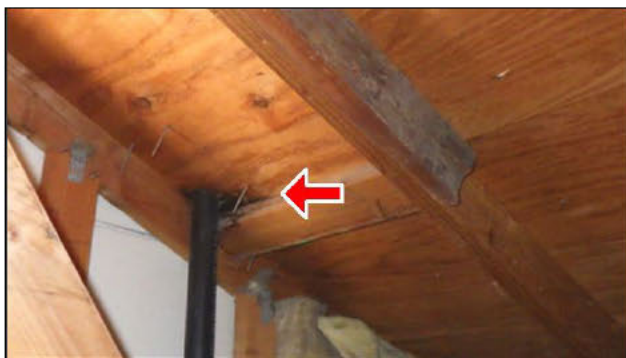
2.5 Item 1(Picture)

Water signs on plywood and containers resulting from a roof leak found at various areas in the attic. I am unable to determine if leak has been corrected. A qualified roofing contractor should inspect further and correct as needed.

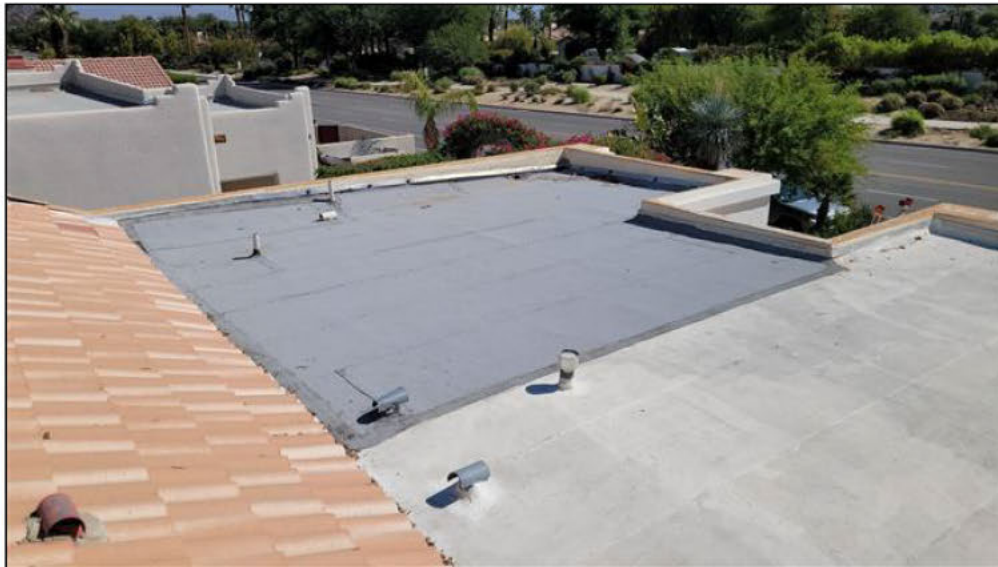
Low slope roof view

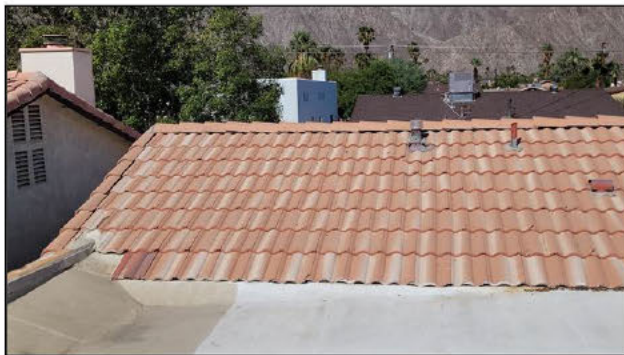
3.0 Item 1(Picture)

🔍 (1) Tile roof covering appears older and shows normal wear for it's age. Tile roofing has an underlayment system which can deteriorate over time and may need to be replaced. Underlayment is not visible in all areas and could not be evaluated. We are unable to determine remaining useful life expectancy of the underlayment. Recommend a licensed roofing contractor evaluate further.

The tile roof underlayment is deteriorated at front of home. This does not appear adequate. It should be properly repaired or replaced. A qualified contractor should inspect further and correct as needed.

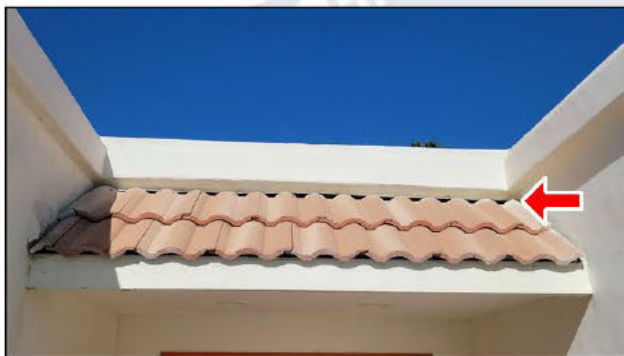
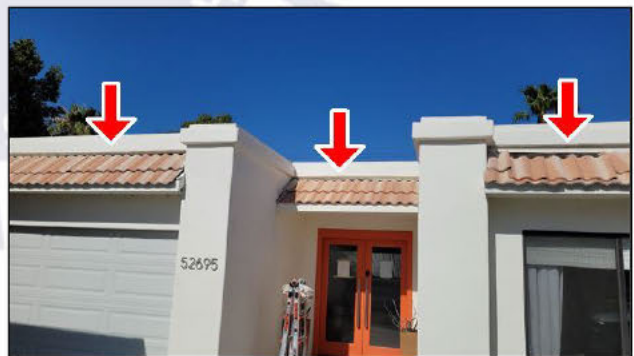
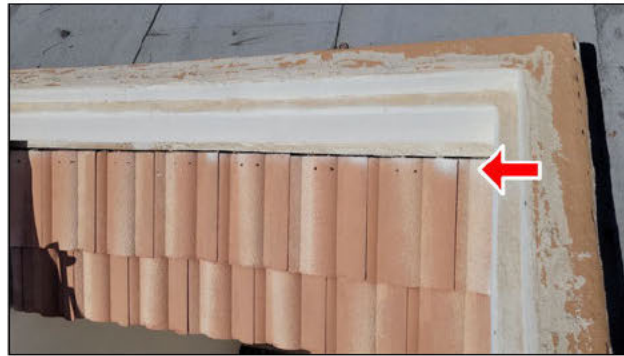
3.0 Item 3(Picture)

🔍 (2) The tile roof was installed improperly at front of home. Tile is improperly lapped. This does not appear adequate. It should be properly repaired or replaced. A qualified contractor should inspect further and correct as needed.

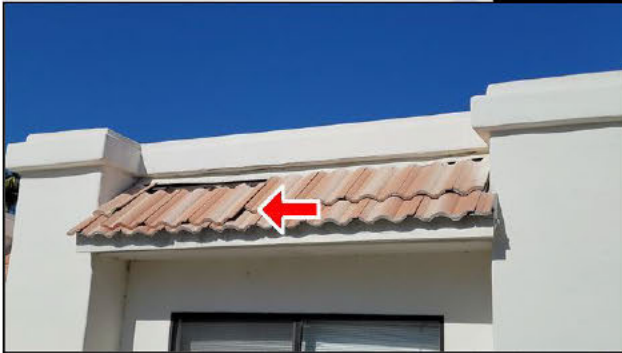
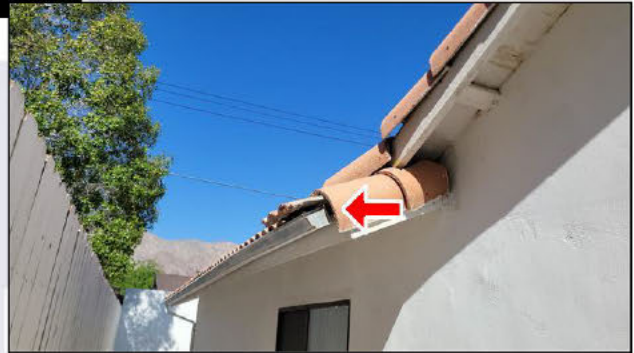
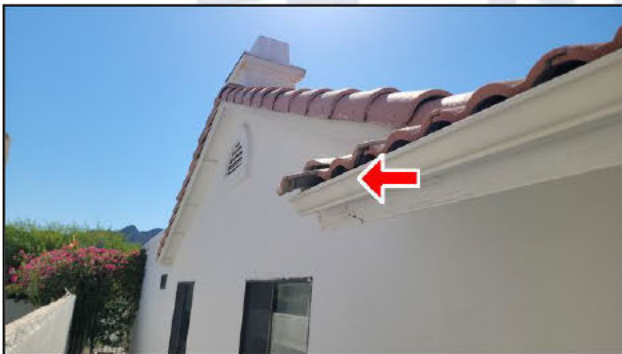
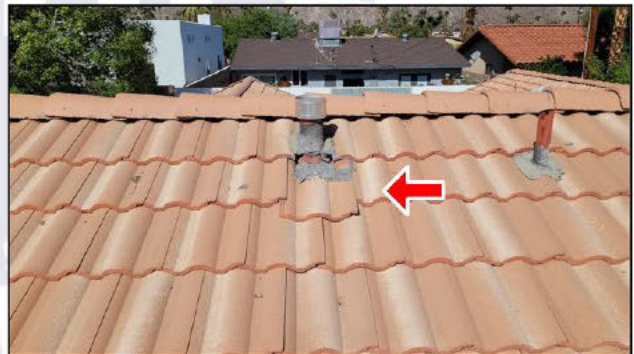
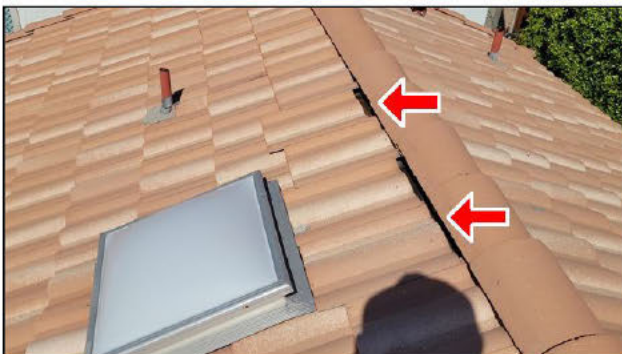
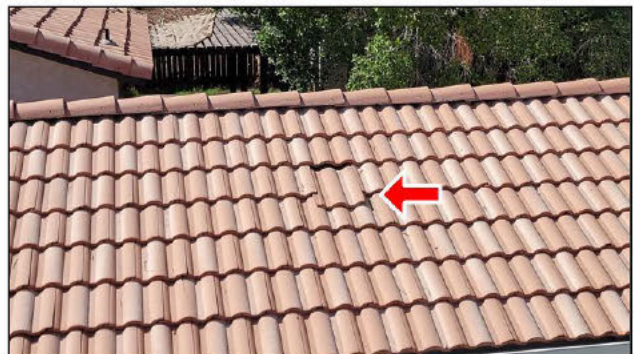
3.0 Item 6(Picture)

⚠ (3) The tile roof has a number of loose tiles at various areas. This does not appear adequate. It should be properly repaired or replaced. A qualified contractor should inspect further and correct as needed.

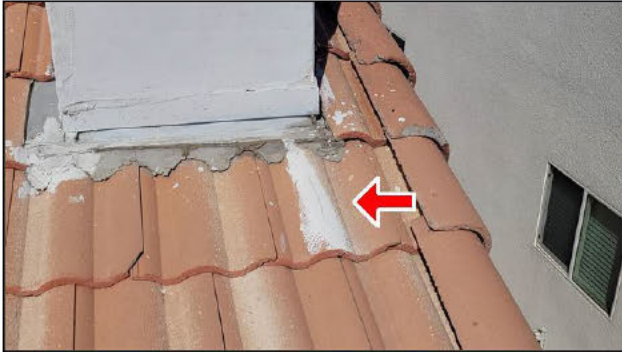
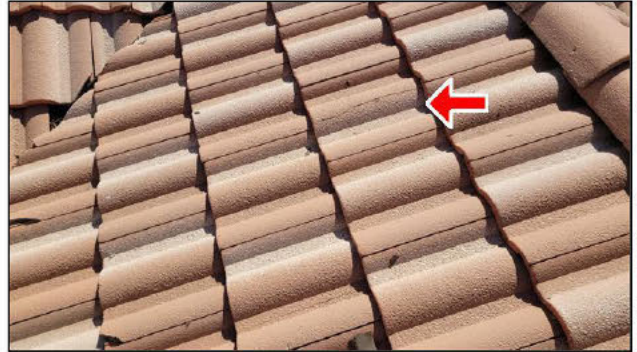
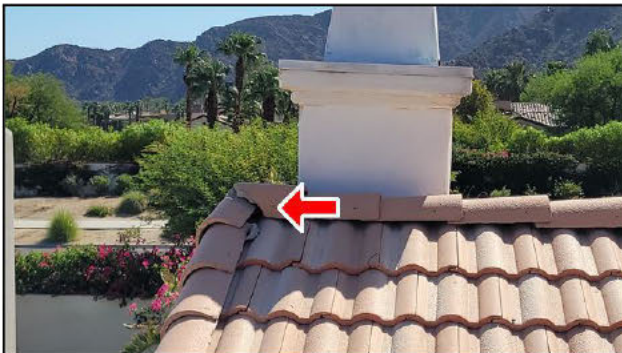
3.0 Item 12(Picture)

👉 (4) The tile roof has a number of cracked/damaged tiles at various areas. Some of the damaged tiles have been repaired, however the repairs are not permanent and tiles should be replaced. Cracked or damaged tiles need replacement. A qualified contractor should inspect further and correct as needed.

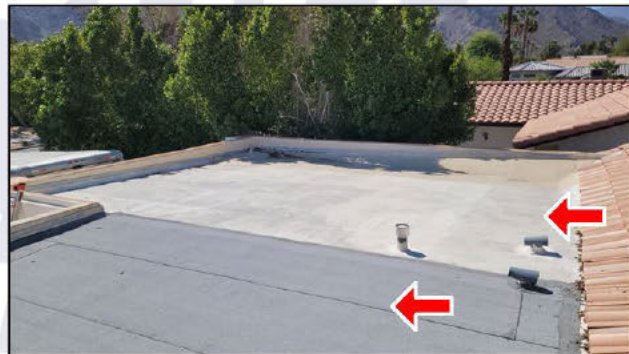
3.0 Item 16(Picture)

👉 (5) The low slope roof covering has been repaired at front of home. I am unable to determine if this repair will leak or fail. Recommend further evaluation by proper licensed specialist.

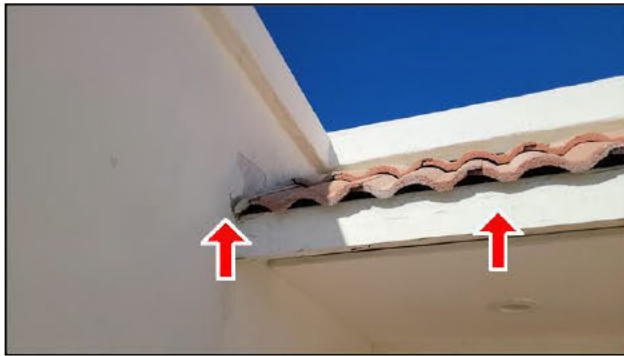
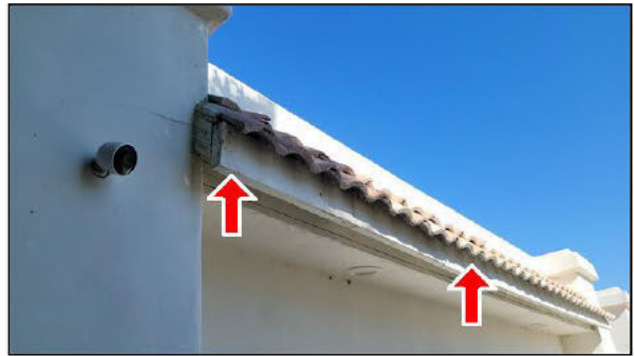
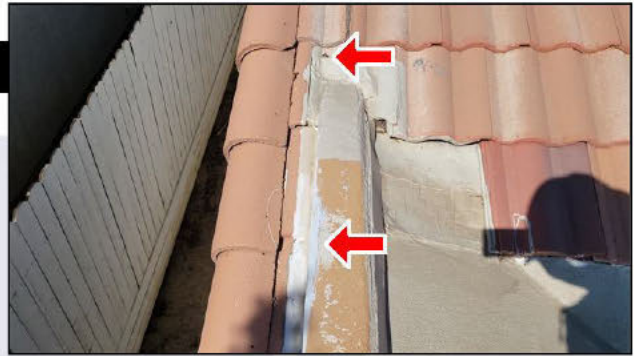
3.1 Item 1(Picture)

👉 (1) Metal drip edge and flashing are missing at front of home. This does not appear adequate. It should be properly repaired or replaced. A qualified roofing contractor should inspect further and correct as needed.

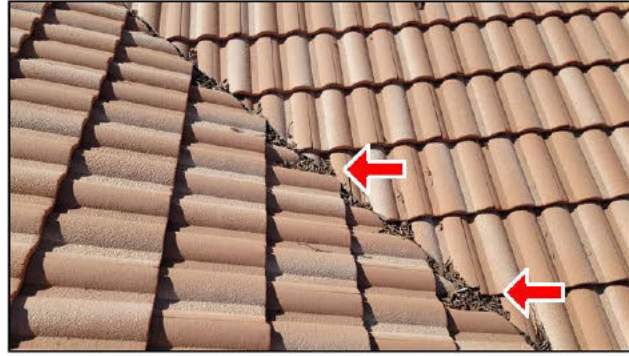
3.1 Item 6(Picture)

🔧 (2) Pan and valley flashings have debris built up and need correcting. These areas require regular maintenance and cleaning. Recommend correct as necessary

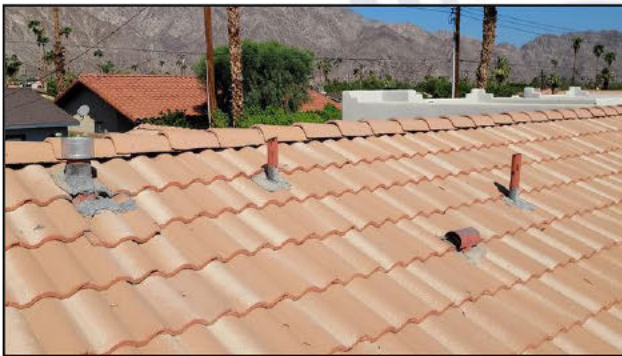
3.2 Item 1(Picture)

🔧 (1) Penetrations through roof do not appear to have proper boot flashing installed that should weave into roof tiles. Pipes are sealed with [REDACTED] which is cracked and needs re-sealing. While some jurisdictions do allow this, we recommend correction as necessary.

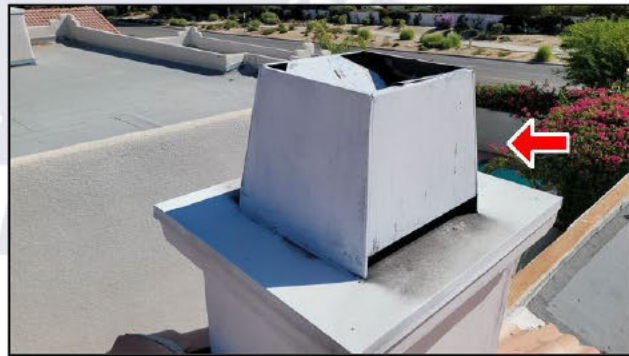
3.2 Item 3(Picture)

🔧 (2) Chimney is missing an approved termination cap. Recommend correct as necessary.

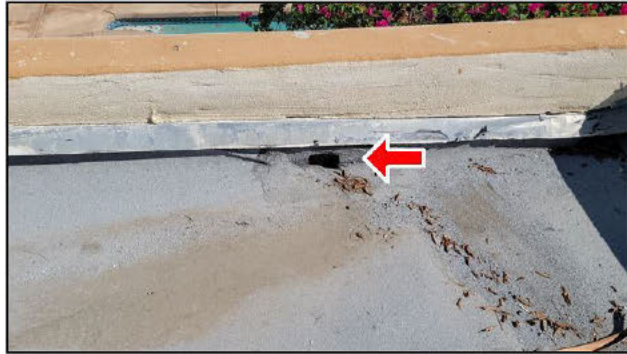
3.3 Item 1(Picture)

☞ (1) Rain gutters and drain lines are not installed on all areas of home. Although this region does not typically have a large amount of rainfall, gutters and drain lines are needed or erosion or water intrusion may occur.

☞ (2) Roof drains are very susceptible to leaks. We do not leak test roofing systems. Drains are mostly covered and not visible for inspection. Small leaks can occur even when visually inspected. It is always recommended to have a qualified licensed roofing contractor evaluate drains and maintain on a regular basis.

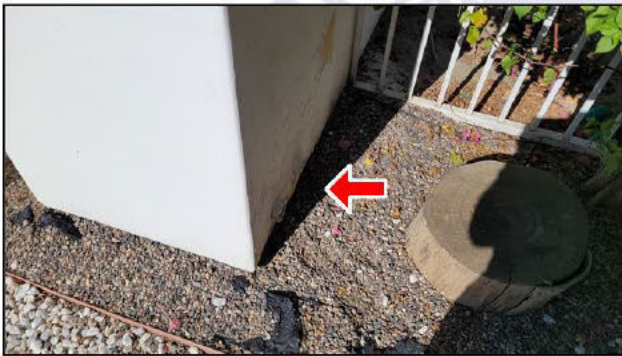
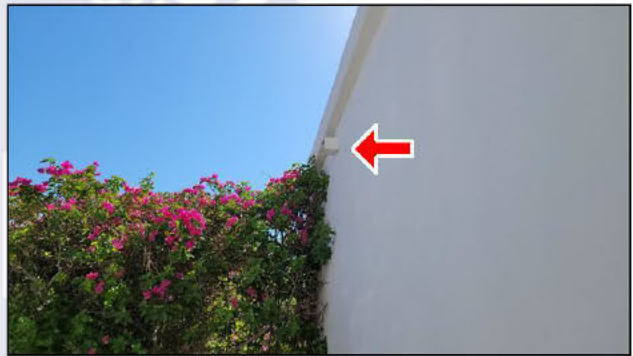
3.3 Item 2(Picture)

☞ (3) Roof drains should have downspouts, elbows, splashblocks installed and proper drainage away from home at all locations.

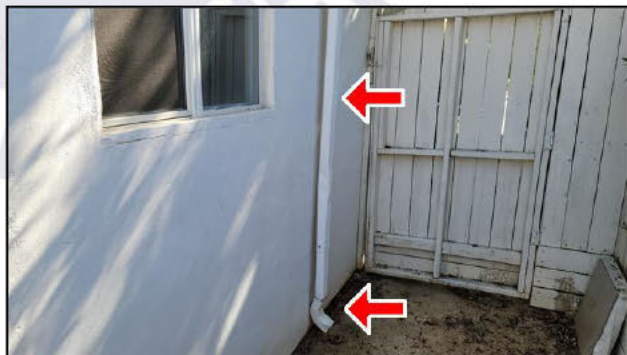
3.3 Item 4(Picture)

☞ (4) The downspout is dented and loose at the left side of home (facing front). Erosion can continue or become worse if not corrected. A qualified person should repair or replace as needed.

The downspout needs an extension and a buried drain line to carry water away from the home at the left side (facing front).

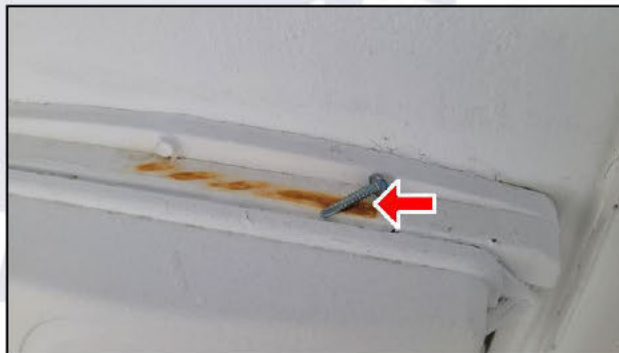
4.1 Item 1(Picture)

🔧 (1) Screws that hold deadfront cover on electrical main panel should be non-piercing to prevent damage to wiring. Recommend correct with proper screws.

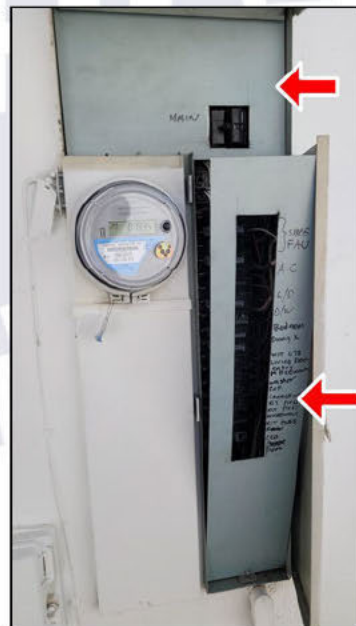
4.1 Item 5(Picture)

🚨 (3) Panel deadfront covers appear improper (missing UL listing tag) and do not fit panel properly and need repair or replace.

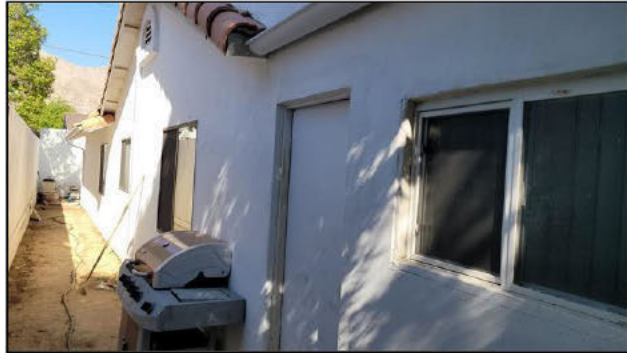
4.3 Item 1(Picture)

🔧 **+** (1) The light fixture is missing at the garage side entry. This is a requirement and should be corrected. A qualified licensed electrician should inspect further and correct as needed.

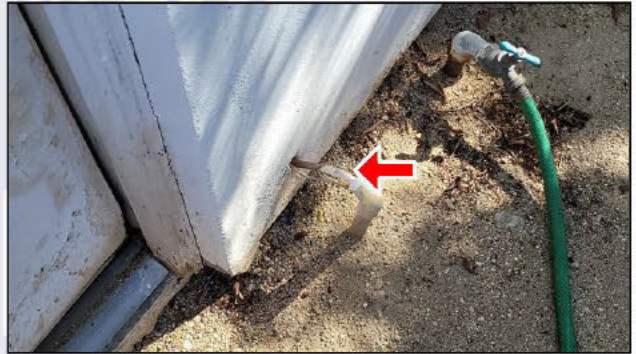
4.3 Item 3(Picture)

🔧 **+** (2) Exposed wiring at unknown [REDACTED] outh side of home). Further inspection is needed by a qualified licensed electrician. A qualified licensed electrician should inspect further and correct as needed.

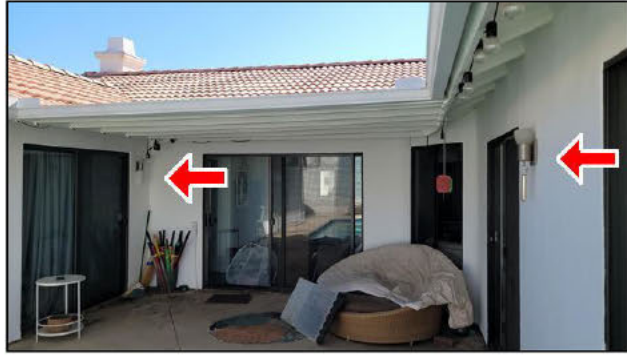
4.3 Item 5(Picture)

⚠️ (4) The light fixture (s) may not be rated for wet location use at the rear patio. This is a safety issue that needs to be corrected. A qualified licensed electrician should inspect further and correct as needed.

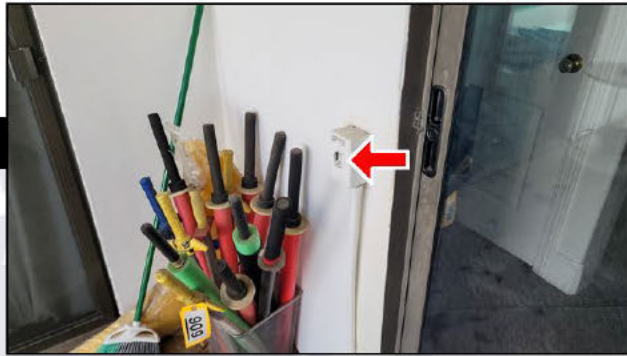
4.3 Item 6(Picture)

⚠️ (5) The wall switch has a damaged "cover-plate" at the rear patio. This is a safety issue that needs to be corrected. A qualified licensed electrician should inspect further and correct as needed.

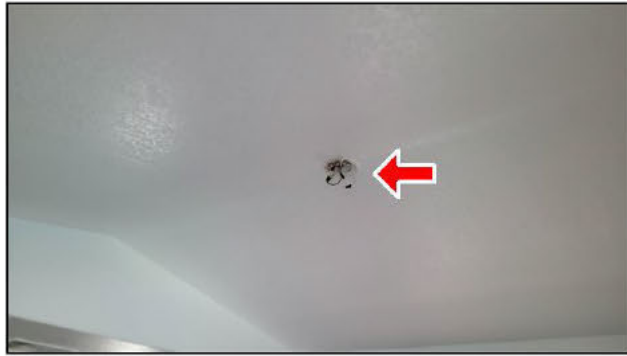
4.3 Item 11(Picture)

🔧 + (7) The light fixture is missing at the Den. Wiring is exposed(dangerous). This is a safety issue that needs to be corrected. A qualified licensed electrician should inspect further and correct as needed.

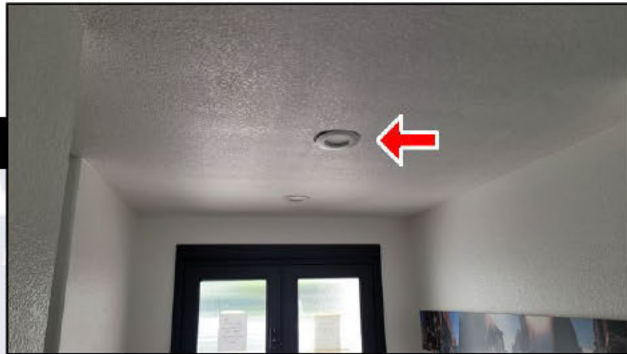
4.3 Item 12(Picture)

🔧 + (8) The light fixture (s) are loose and do not work (try bulb first) at the main entry. Further inspection is needed by a qualified licensed electrician. I recommend repair or replace as necessary.

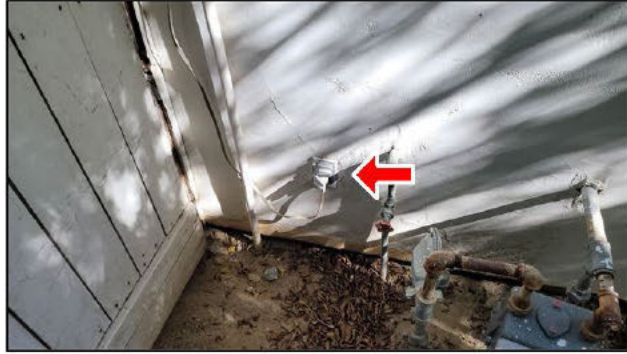
4.4 Item 1(Picture)

🔧 + (1) The exterior outlet at the left side of home (facing front) is loose in the wall, and needs to be secured properly and needs a weatherproof cover installed over cords. This is a safety issue that needs to be corrected. A qualified licensed electrician should inspect further and correct as needed.

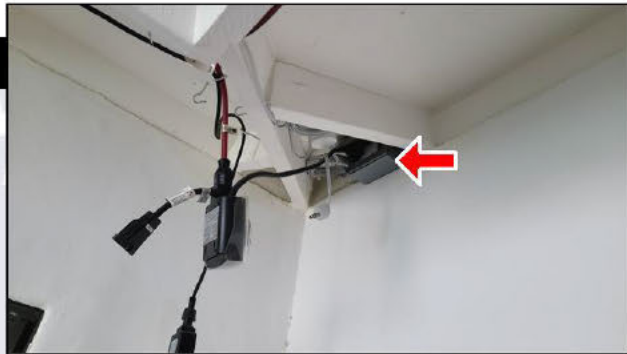
4.4 Item 2(Picture)

🔧 + (2) The GFCI outlet (Ground Fault Circuit Interrupt) at the rear of home needs a weatherproof cover installed over cords. This is a safety issue that needs to be corrected. I recommend repair or replace as necessary.

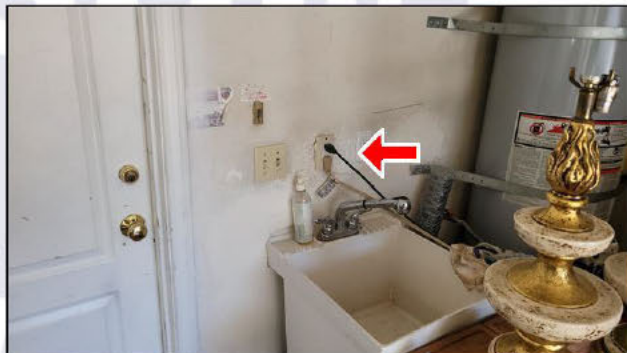
4.4 Item 3(Picture)

🔧 + (3) GFCI (Ground Fault Circuit Interrupter) outlet at the garage is loose in the wall, and needs to be secured properly. This is a safety issue that needs to be corrected. A qualified licensed electrician should inspect further and correct as needed.

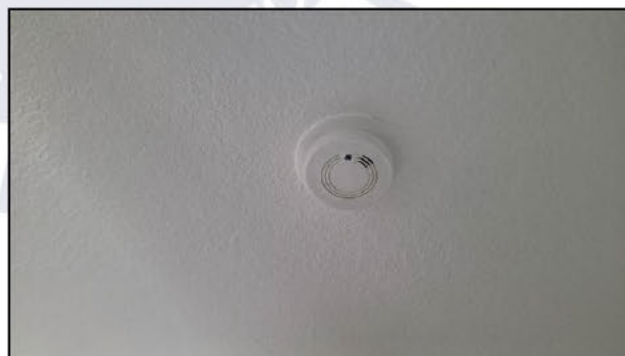
4.7 Item 1(Picture)

🚧 (2) It should be noted that some smoke alarms appear to be very old and may not function properly. Smoke alarms should have 10 year batteries and have labels with date of installation to meet current requirements. I recommend replacing older units for safety.

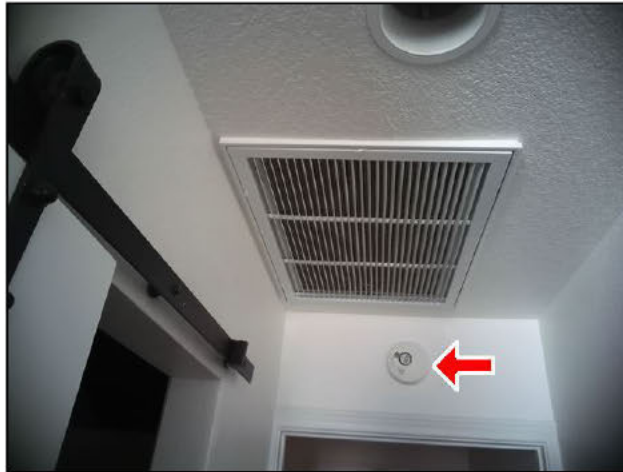
4.7 Item 2(Picture)

🚩 (3) The smoke alarms need relocating away from HVAC registers. This may divert smoke away from alarm and alarm may not operate when HVAC system is operating. This can be a safety issue. Recommend correct as necessary.

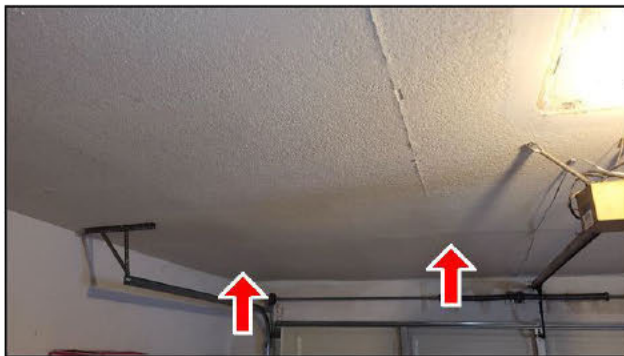
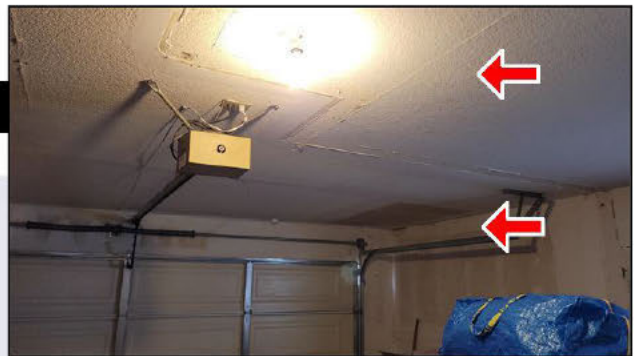
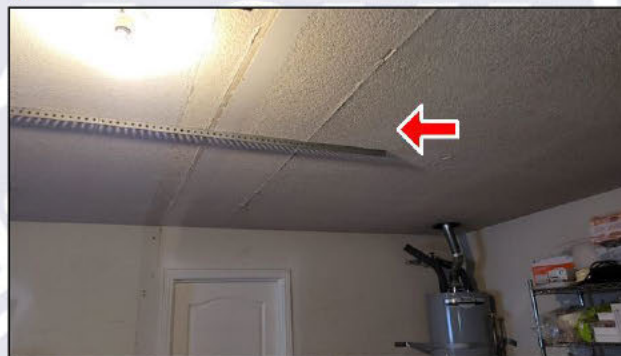
5.0 Item 1(Picture)

🔧 The Sheetrock on the ceiling has multiple cracks, is peeling or loose and shows repair signs at the garage. We are unable to determine the cause or extent of damage. Recommend further evaluation by proper licensed specialist.

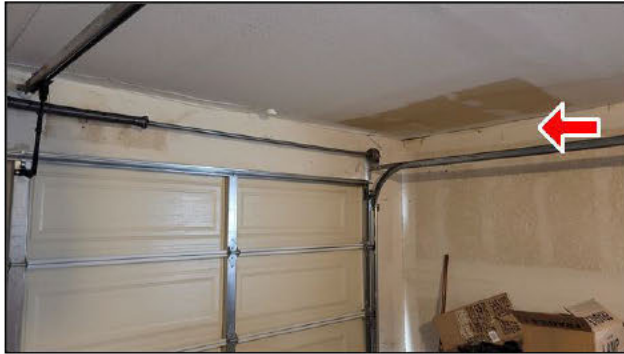
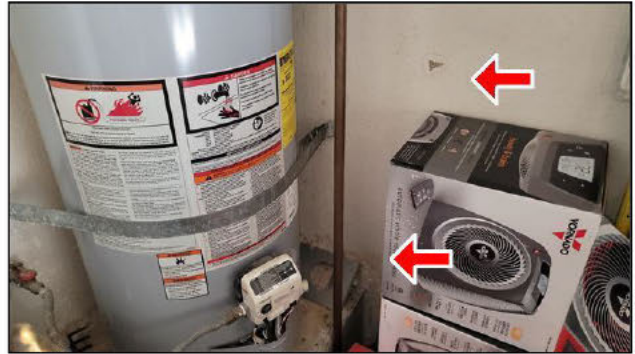
5.1 Item 2(Picture)

🔧 (2) The sheetrock on the wall shows wet stains indicating moisture intrusion did or still may occur at the garage. We are unable to determine the cause or extent of damage. Recommend further evaluation by proper licensed specialist.

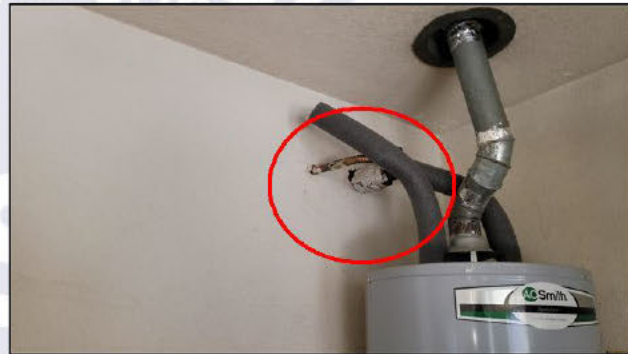
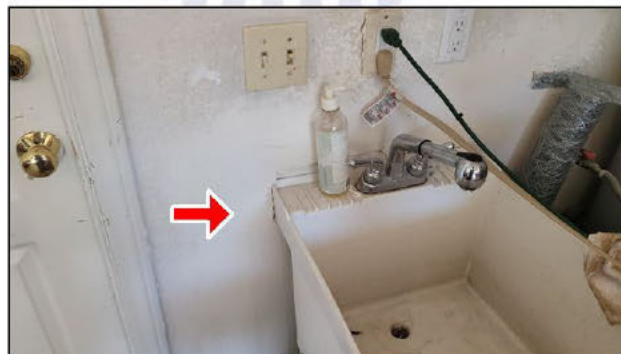
5.1 Item 5(Picture)

🔧 + (3) The fire protection wall that [REDACTED] from heated space has holes that can allow flames to enter wall if a fire were to start in the garage. This is considered unsafe until corrected. A qualified person should correct for safety.

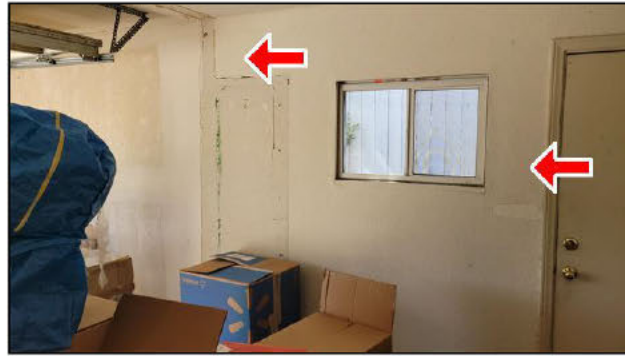
5.1 Item 7(Picture)

🔧 (4) The sheetrock on the wall shows signs of repair and is unfinished at the garage. We are unable to determine the cause for this. A qualified contractor should inspect further and correct as needed.

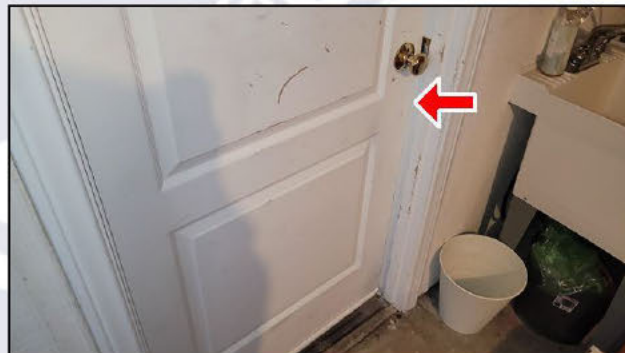
5.3 Item 1(Picture)

🔧 **+** Unable to determine if door between home and garage is fire rated(no marking). Recommend proper licensed specialist inspect further.

The door from home to garage is missing weather-stripping. This is part of the fire rating for this door. A qualified person should repair or replace as needed.

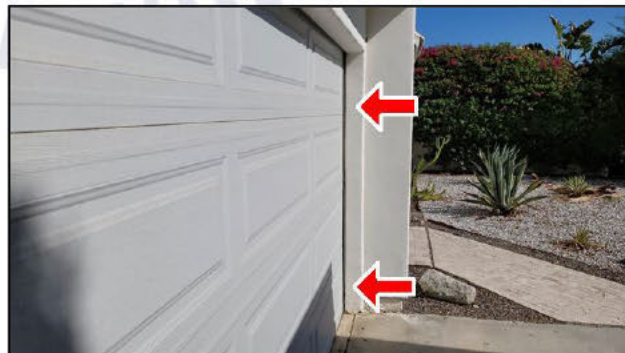
5.4 Item 1(Picture)

🔧 The garage door at the front of home does not close or seal tight at opening. This is a maintenance issue and is for your information. I recommend correct as necessary.

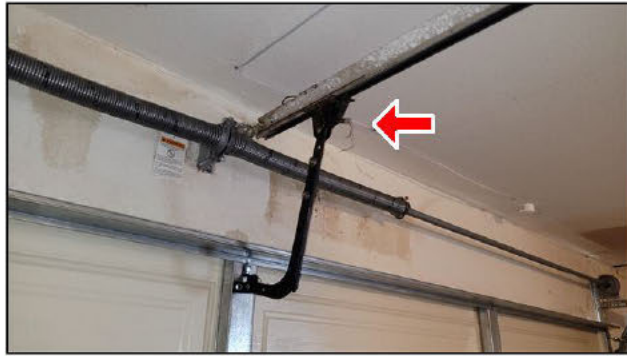
5.5 Item 1(Picture)

🔧 (1) The automatic opener for garage door at the front of home is missing the safety release cord. A repair or replacement is needed. I recommend correct as necessary.

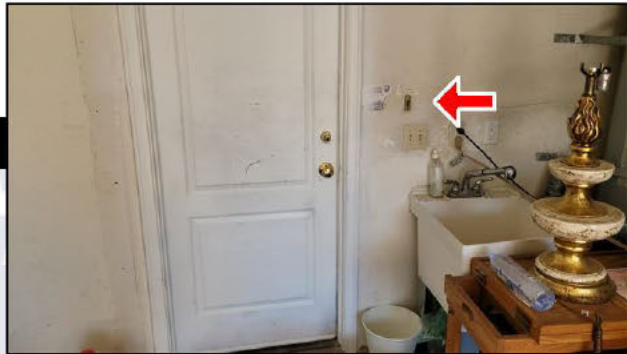
5.5 Item 2(Picture)

🔧 + (2) The automatic opener for garage door at the front of home has button installed too low (under 5 feet) on the wall. This is considered unsafe and needs correcting. I recommend correct as necessary.

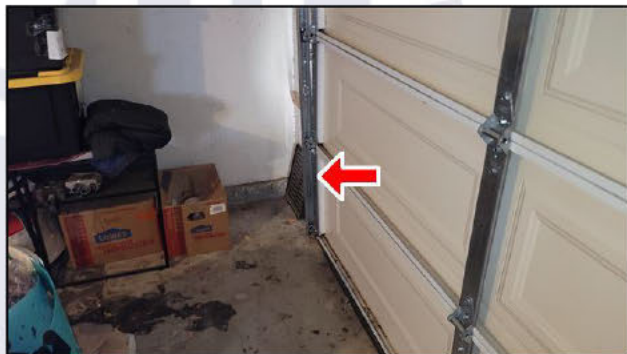
5.5 Item 3(Picture)

🔧 + (3) The automatic opener for garage door at the front of home does not have sensors installed so opener will reverse if door is blocked. Doors that will not reverse when met with resistance can kill a child or pet. This is considered unsafe and needs correcting. While this may not have been required at the time of construction, we recommend upgrading for safety.

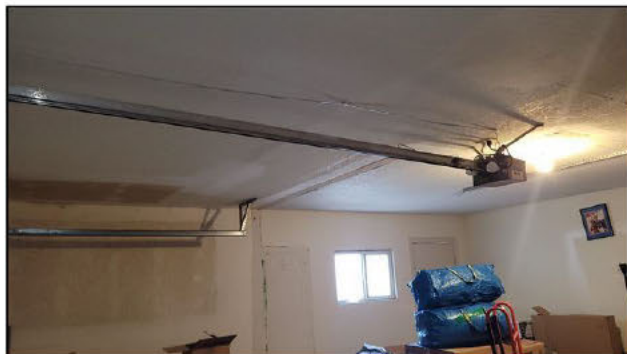
5.5 Item 4(Picture)

🔧 + (4) The automatic opener for garage door at the front of home will not reverse when met with resistance. Doors that will not reverse when met with resistance can kill a child or pet. This is considered unsafe and needs correcting. A qualified person should repair or replace as needed.

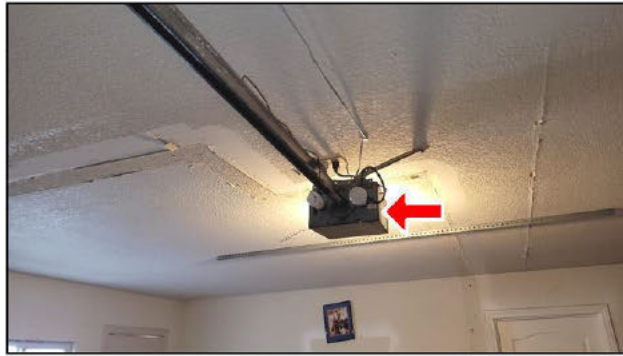
5.5 Item 5(Picture)

🔧 (5) The automatic opener for garage door at the front of home is missing light cover. A repair or replacement is needed. I recommend correct as necessary.
