Inspection Report

**Schultz Property
Inspection**

Address: 52695 Avenida Bermudas, La
Quinta, CA 92253

Inspector: Bill Schultz
P.O. Box 3222
Cathedral City, CA 92235
(760) 904-4798
8/30/2023

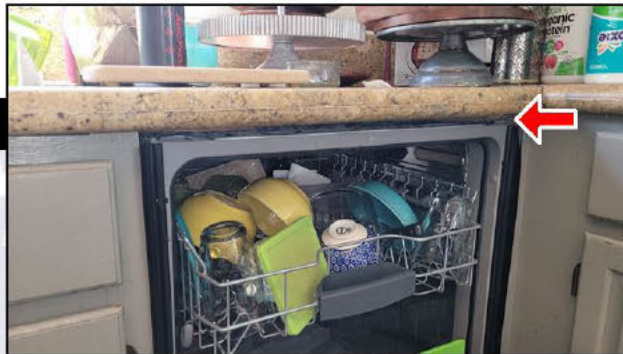
6.0 Item 4(Picture)

🔧 (2) The dishwasher is loose and needs securing to underside of countertop (using a proper length screw). I recommend repair as necessary.

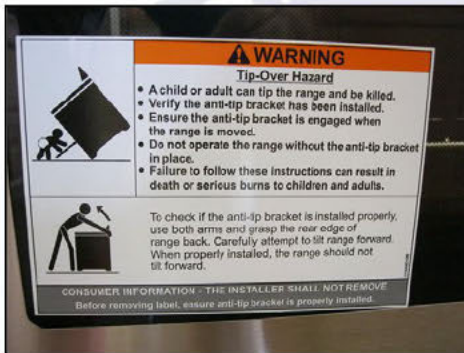
🚧 No "anti tip" bracket installed on the stove/range to prevent unit from tipping over if oven door were to be used for a step. This is a safety issue. Recommend installation of "anti tip" bracket for safety.

6.1 Item 1(Picture) No anti-tip

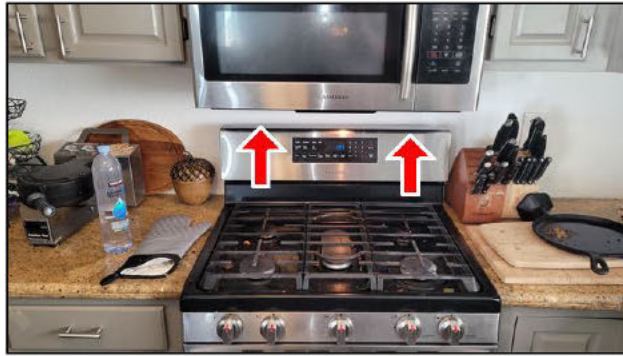
6.2 Item 1(Picture)

🔧 Microwave appears installed too low to burners. Recommend refer to manufacturers minimum distance requirements. .

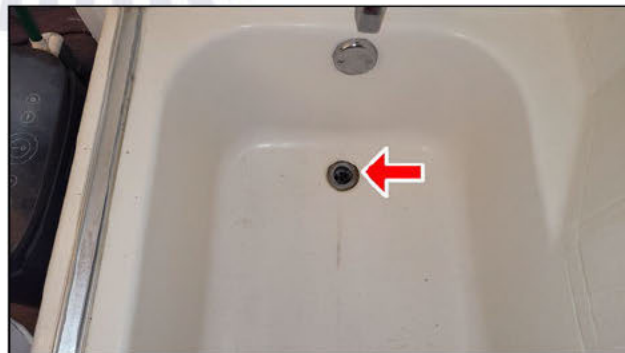
7.0 Item 1(Picture)

🔧 (1) The stop-valve is missing at the south Hall Bath tub (s). Repairs are needed. I recommend repair or replace as needed.

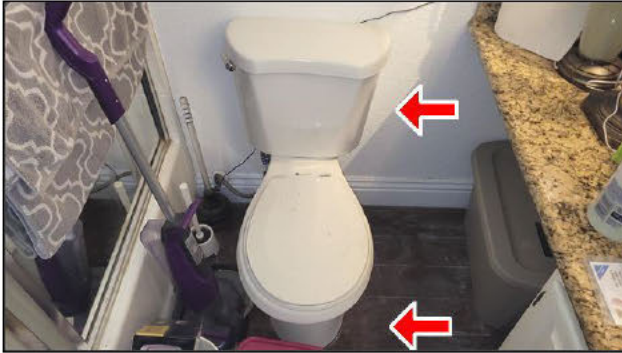
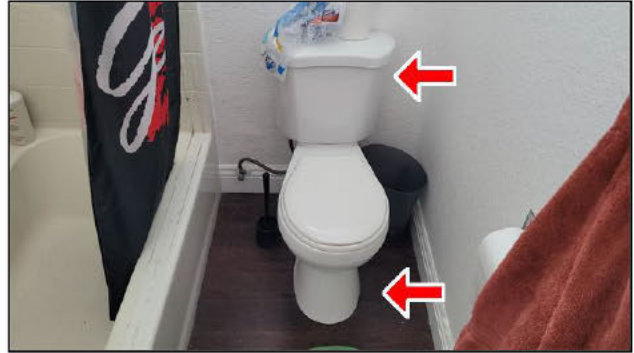
7.0 Item 2(Picture)

🔧 (2) The toilet is loose at floor, tank is loose and leaks at floor at the hall bath (s). Repairs are

needed. A qualified licensed plumber should repair or correct as needed.

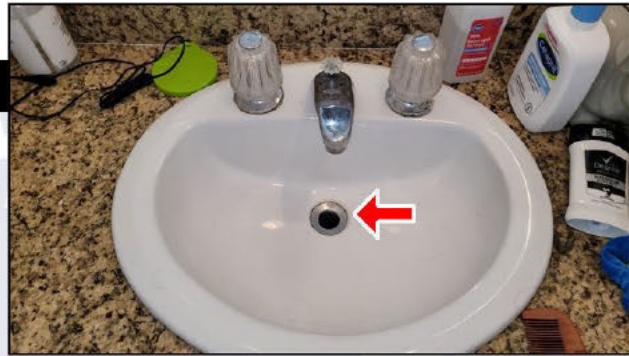
7.0 Item 4(Picture)

🔧 (3) The stop-valve is missing at the north Hall Bath sink. Repairs are needed. I recommend repair or replace as needed.

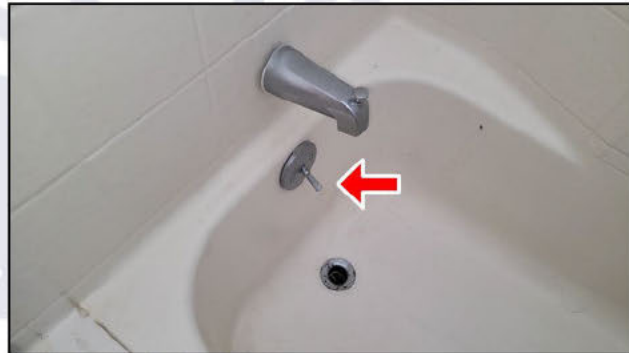
7.0 Item 5(Picture)

🔧 (4) The stop-valve linkage is damaged at the north Hall Bath tub. Repairs are needed. A qualified licensed plumber should repair or correct as needed.

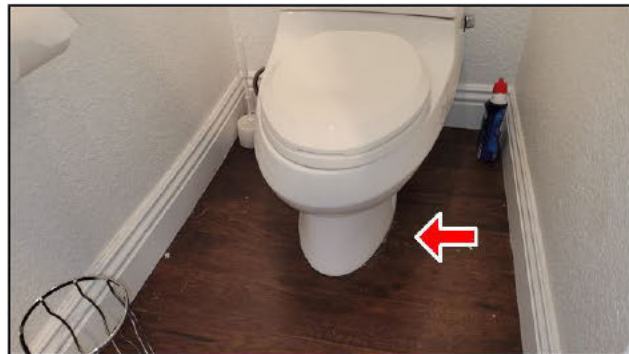
7.0 Item 6(Picture)

🔧 (5) The toilet is loose at floor at the primary bath. Repairs may involve re-setting the toilet on a new wax seal. I recommend a qualified licensed plumber repair or correct as needed.

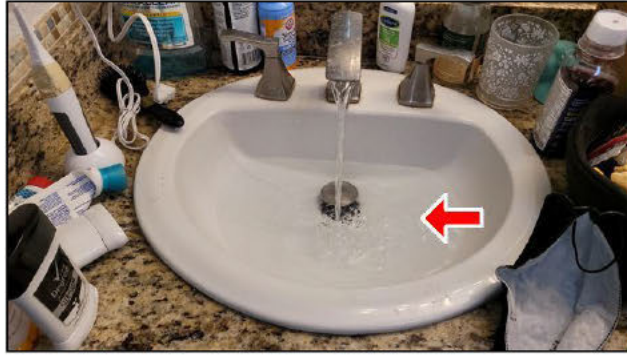
7.0 Item 7(Picture)

🔧 (6) Sink drain is slow or clogged at primary bath. I recommend repair or replace as needed

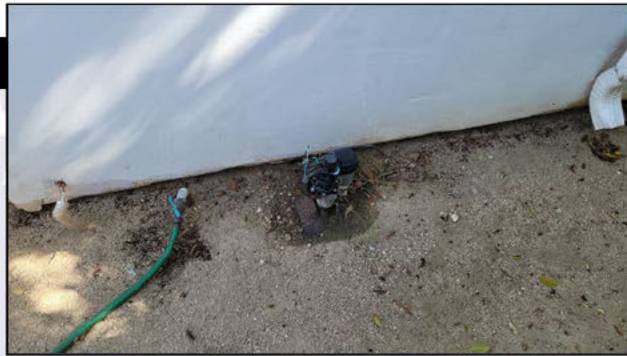
7.1 Item 1(Picture)

🔧 (1) Irrigation systems are beyond the scope of the inspection and were not tested or evaluated. Irrigation systems are required to be inspected by proper specialist according to California Assembly bill No. 2371 for proper operation. Recommend further evaluation by proper specialist.

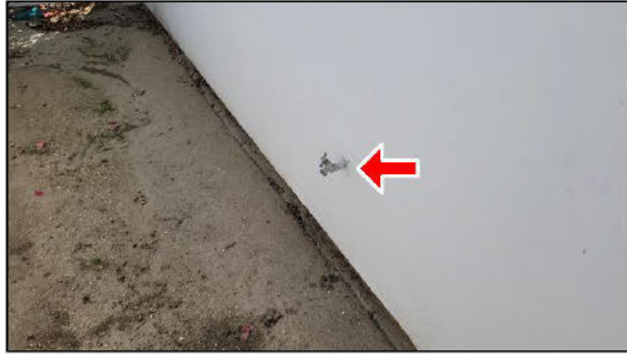
7.1 Item 4(Picture)

🔧 (3) The hose bib is loose, and needs securing to wall at the right side (facing front). Repairs are needed. A qualified licensed plumber should repair or correct as needed.

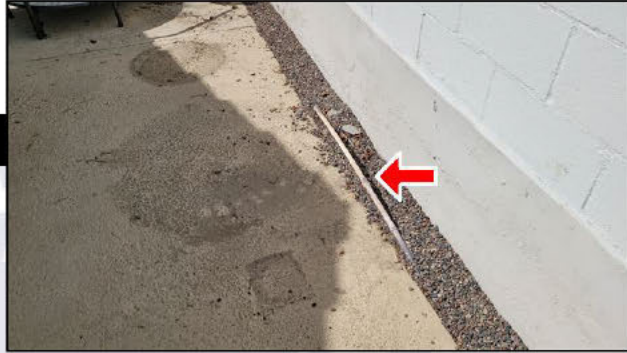
7.1 Item 5(Picture)

🔧 (4) Exterior PVC plumbing is exposed and subject to damage and deterioration. This is for your information. Recommend repair or replace as needed.

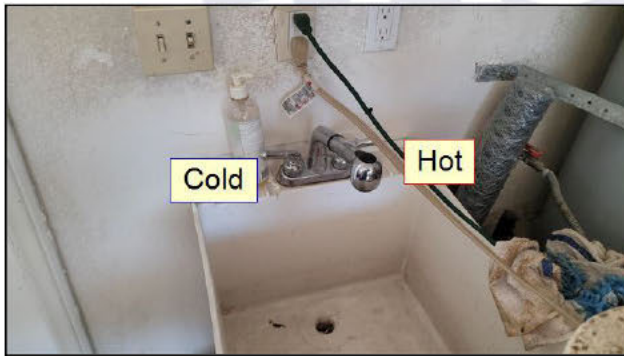
7.1 Item 6(Picture)

🔧 (5) The sink faucets hot control and are cold control is reversed (hot is cold, cold is hot) at the garage and kitchen. This is not considered up to today's standard. I recommend correct as necessary for safety.

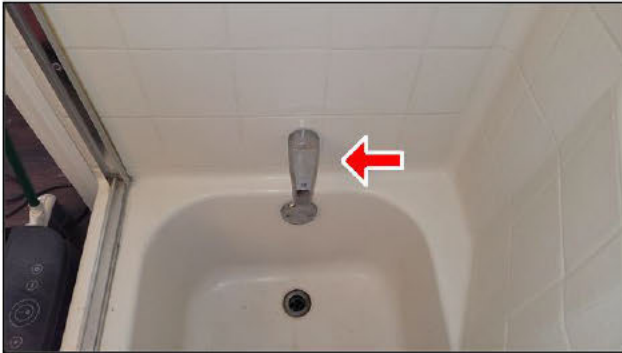
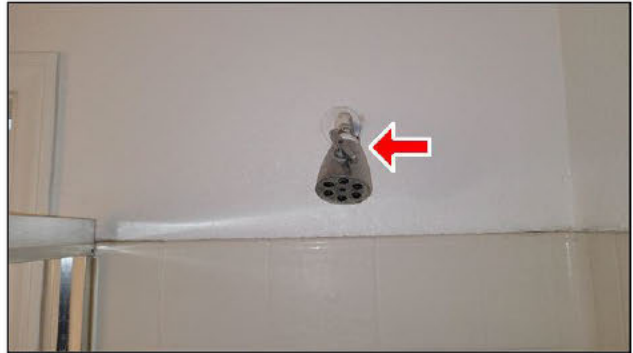
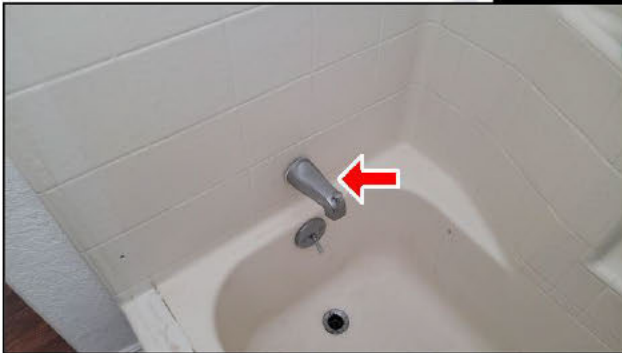
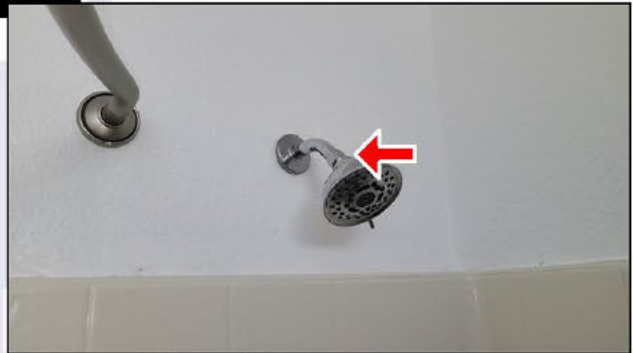
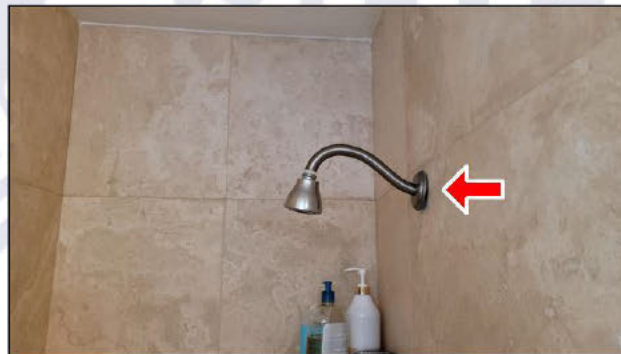
🔧 (6) The tub spout and shower arm are loose in wall at the hall bath (s). Repairs are needed. A qualified licensed plumber should repair or correct as needed.

The shower arm is loose in wall at the primary bath. Repairs are needed. A qualified licensed plumber should repair or correct as needed.

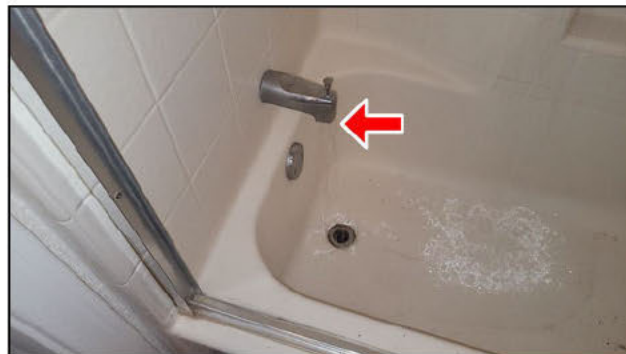
7.1 Item 13(Picture)

🔧 (7) The tub spout diverter leaks a stream through tub spout when shower is on at the south hall bath. When a diverter leaks it can sometimes squirt water back against the cut-out on wall and possibly cause water to go behind wall or simply wastes water. A qualified licensed plumber should repair or correct as needed.

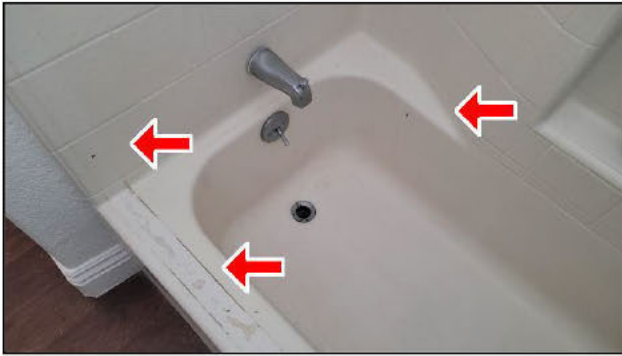
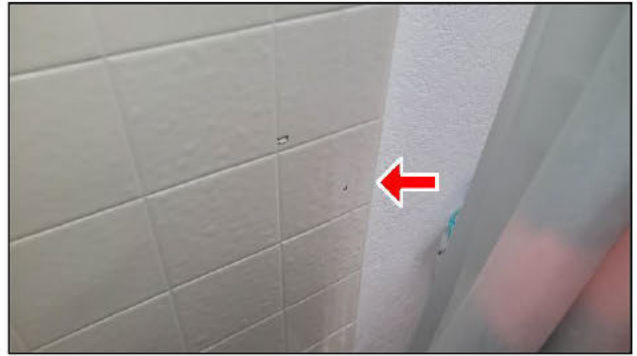
7.1 Item 14(Picture)

🔧 (8) The fiberglass tub is damaged at the north hall bath. This is a cosmetic issue for your information. I recommend repair or replace as needed.

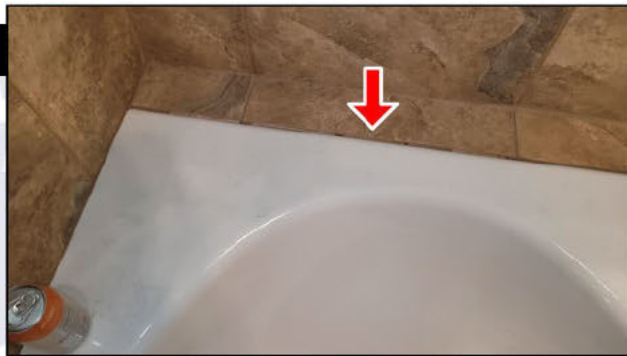
7.1 Item 16(Picture)

🔧 (9) The bathtub needs re-sealing at the primary bath. Repairs are needed. I recommend repair or replace as needed.

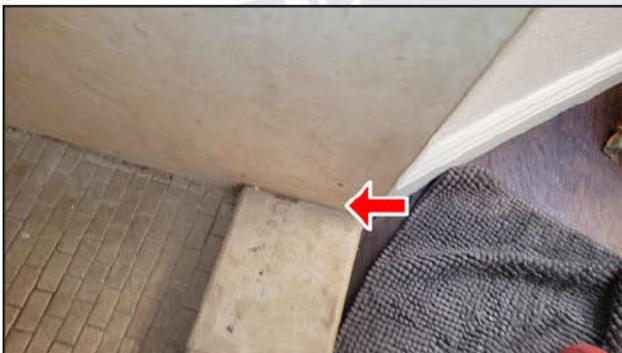
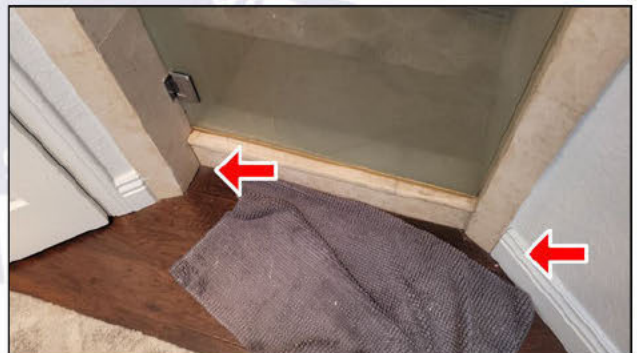
7.1 Item 17(Picture)

🔧 (10) The shower stall needs re-sealing at the primary bath. Repairs are needed. I recommend repair or replace as needed.

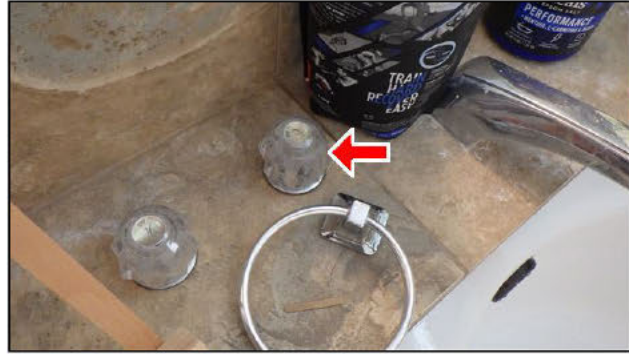
7.1 Item 19(Picture)

🔧 (11) The tub faucets cold control does not have a stopping point at the primary bath. Repairs are needed. A qualified licensed plumber should repair or correct as needed.

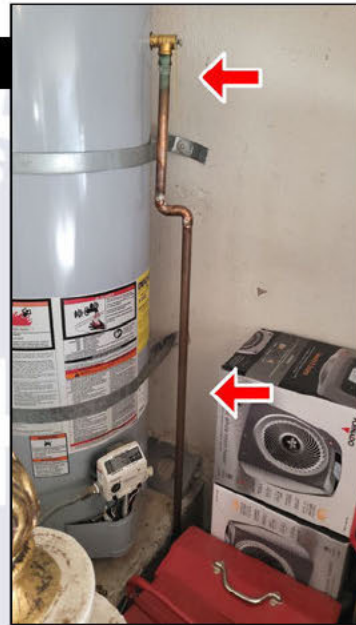
7.2 Item 1(Picture)

🔧 **+** (1) The existing piping for T&P valve on water heater should terminate to exterior. This is a safety issue and should be corrected. I recommend a licensed plumber inspect further and repair as necessary.

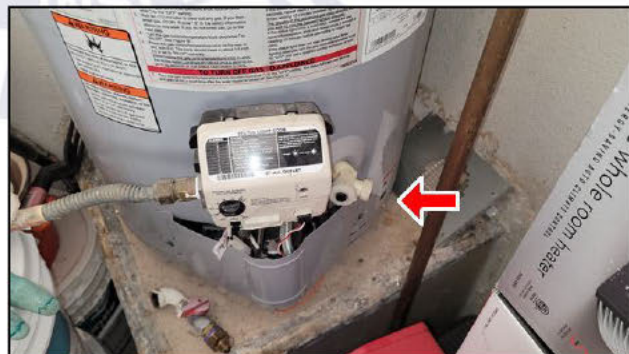
7.2 Item 2(Picture)

🔧 **+** (2) The water heater drain valve should have the knob removed to prevent accidental opening. This is a safety issue and should be corrected. I recommend correct as necessary for safety.

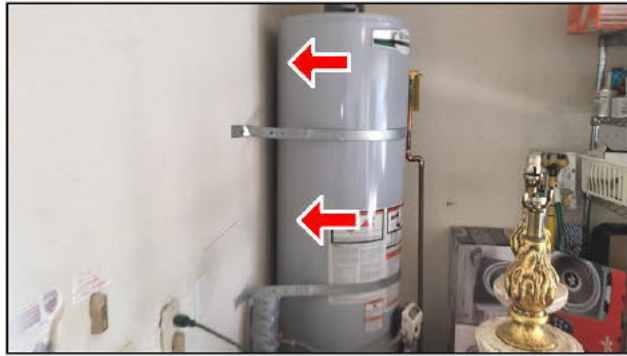
7.2 Item 3(Picture)

🔧 (3) The water heater is strapped but is missing spacers that mount unit solidly to wall. This is a safety issue and should be corrected. A qualified licensed professional should repair as necessary.

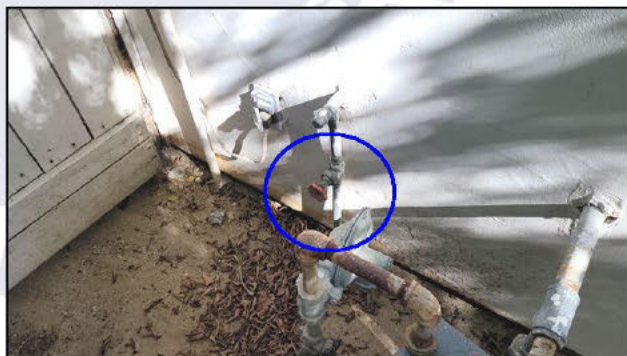
7.3 Item 1(Picture)

Main shut off valve is an older style "gate" valve which is not as reliable as newer style "ball" valves which provide easier operation also. We recommend upgrading to a "ball" valve.

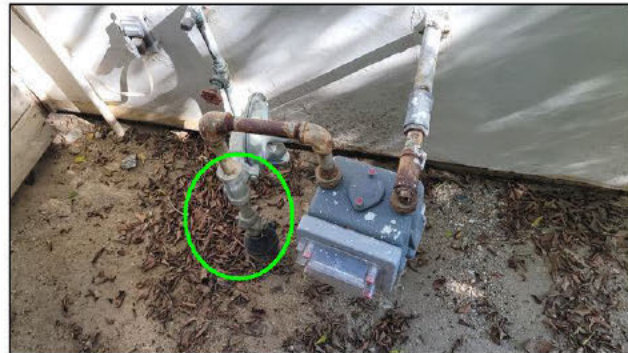
7.5 Item 2(Picture)

The main fuel shut off is at gas meter outside at left side (facing front). The valve will need a wrench to be operated. While not a requirement, in case of emergency, we recommend an earthquake style wrench with a chain be installed to aid shut off in the event of an emergency.

No earthquake safety gas shut off valve noted.

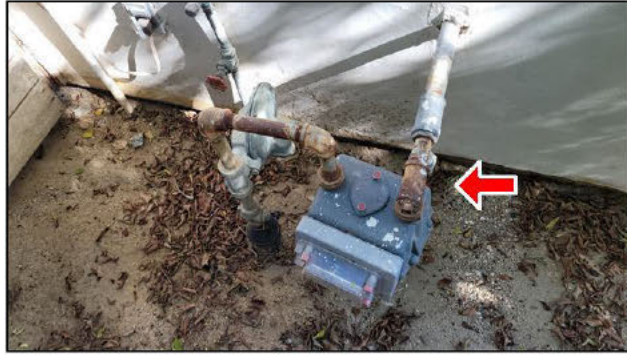
7.6 Item 2(Picture)

🔧 (2) The gas line is rusted at the meter outside. This is a maintenance issue and should be repaired. I recommend prep, prime and paint as needed.

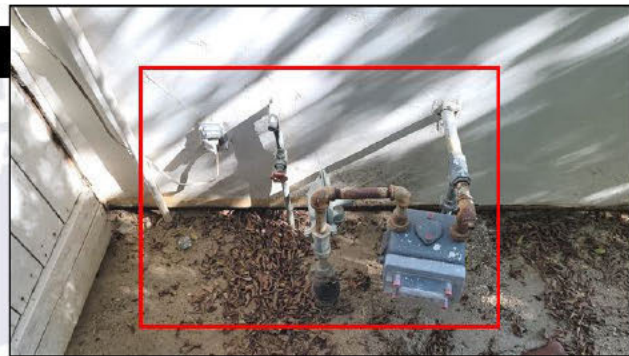
7.6 Item 4(Picture)

🔧 🇨🇦 (3) Gas meter should not have any ventilation or ignition sources within 36 inches. This is a safety issue. Recommend proper licensed specialist evaluate further and correct as necessary.

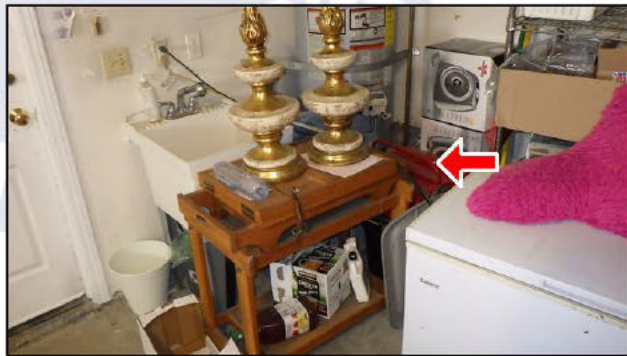
7.6 Item 5(Picture)

🔧 🇨🇦 (4) Gas appliances in garage are not protected from vehicle damage. Typically a post or bollard is required for proper protection. Recommend correct as necessary.

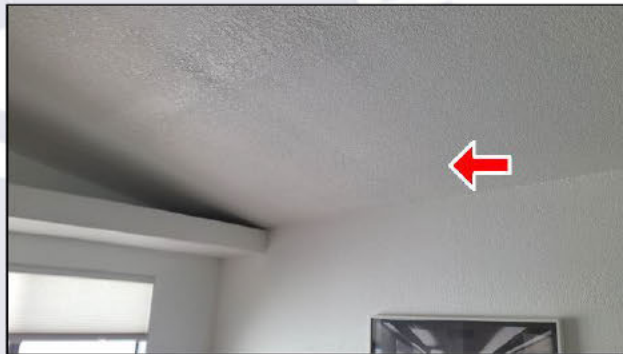
8.0 Item 1(Picture)

🔧 (1) The Sheetrock on the ceiling shows repair signs at the Living Room. We are unable to determine the cause for this. Recommend further evaluation by proper licensed specialist.

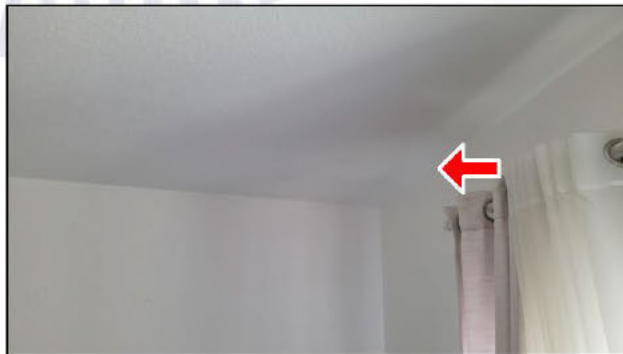
8.0 Item 2(Picture)

🔧 (2) The Sheetrock on the ceiling is blistered as a result from water leak above at the Guest Bedroom. We are unable to determine the cause or extent of damage. Recommend further evaluation by proper licensed specialist.

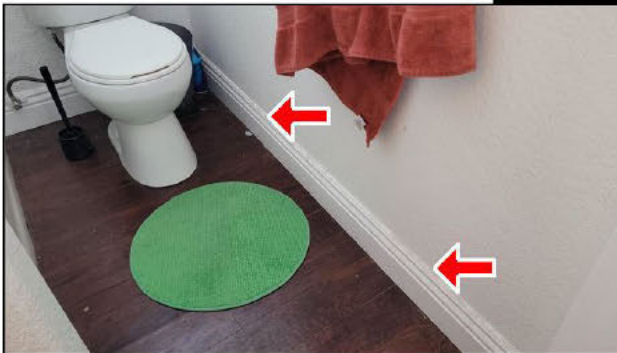
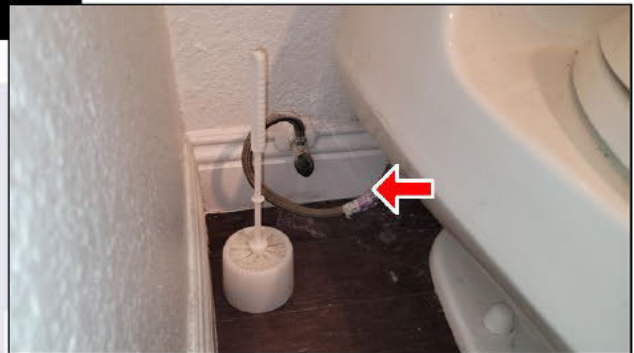
8.1 Item 2(Picture)

🔧 (2) The baseboard on the wall shows staining from unknown sources at the north Hall Bath and Primary Bath. We are unable to determine the cause for this. Recommend further evaluation by proper licensed specialist.

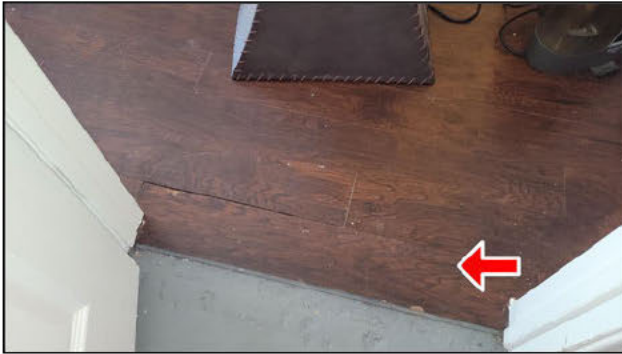
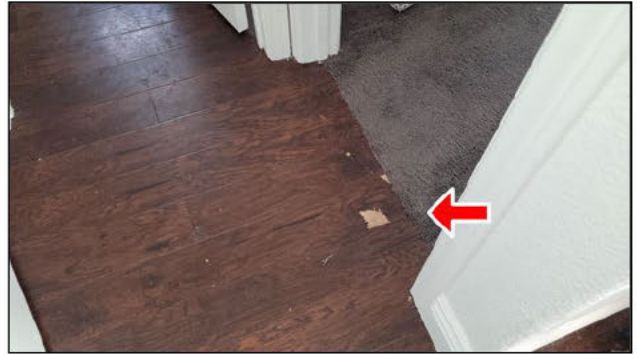
8.2 Item 1(Picture)

👉 (1) The Wood covering is warped or buckled indicating moisture absorption at the bedroom hallways and possibly other areas covered from view. We are unable to determine the cause or extent of damage. Recommend further evaluation by proper licensed specialist.

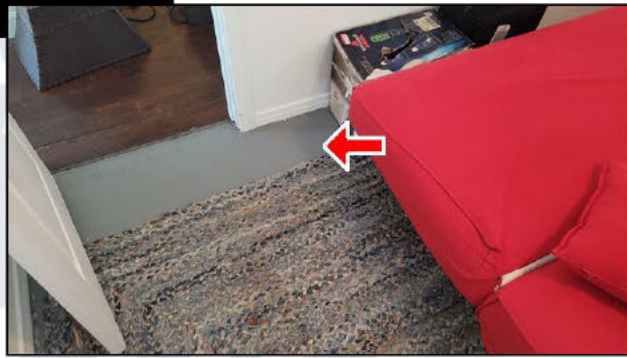
8.2 Item 3(Picture)

👉 (2) The Carpet is missing at the south Guest Bedroom. This is for your information. I recommend correct as necessary.

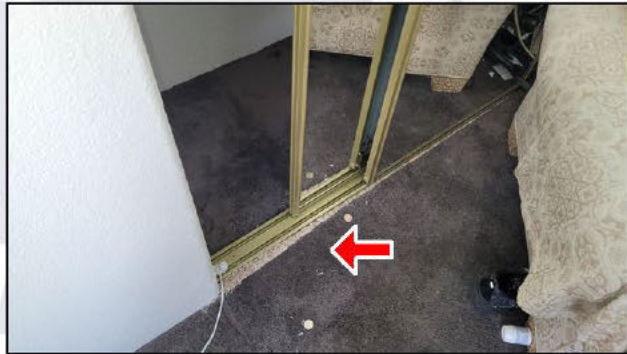
8.2 Item 4(Picture)

👉 (3) The Carpet is mismatched at the rear Guest Bedroom (s). This appears to be a cosmetic issue for your information. I recommend correct as necessary.

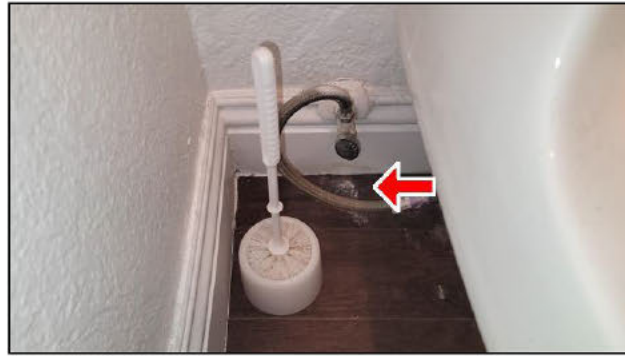
8.2 Item 5(Picture)

🐿 (4) The Wood covering shows wet stains indicating moisture or intrusion did or still may occur at the Primary bath. We are unable to determine the cause or extent of damage. Recommend further evaluation by proper licensed specialist.

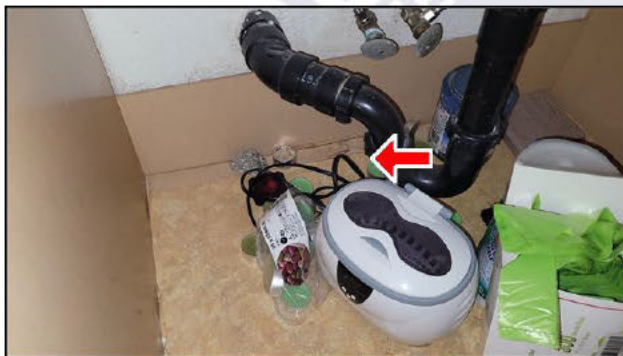
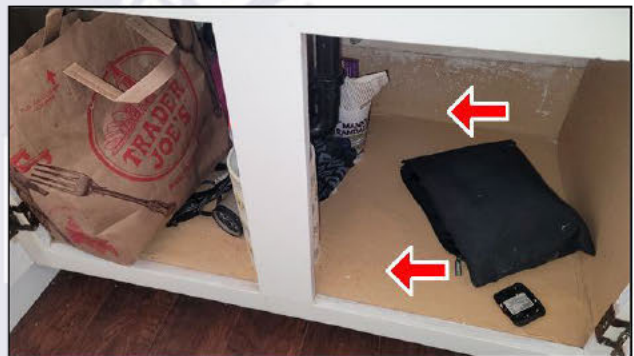
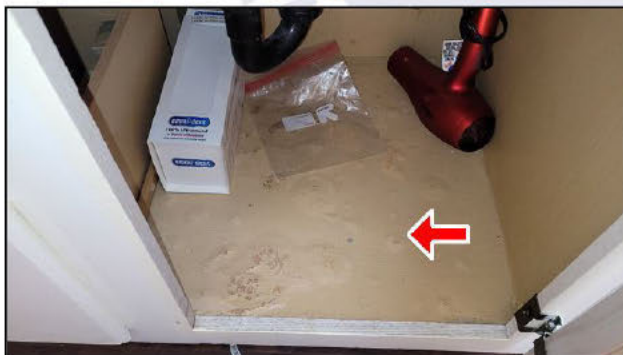
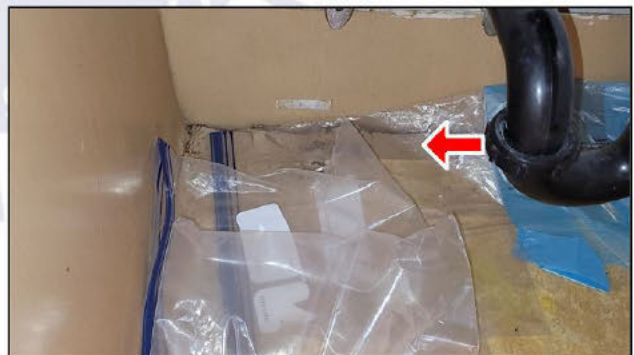
🐿 (1) Base cabinetry in hall and primary baths show signs of moisture damage. We are unable to determine the cause or extent of damage. Recommend further evaluation by proper licensed specialist.

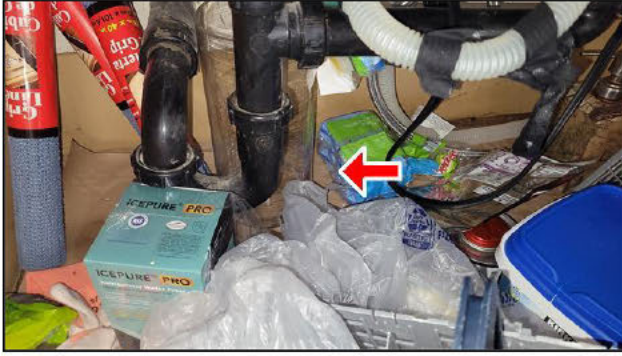
8.4 Item 5(Picture)

🐿 (2) Base cabinetry is damaged from moisture in the kitchen under sink. We are unable to determine the cause or extent of damage. We recommend further evaluation by proper licensed specialist.

Unknown black staining present at the interior of sink cabinetry in kitchen in several areas. We did not inspect, test or determine if this growth is or is not a health hazard. The underlying cause

is moisture. I recommend you contact a proper specialist or expert for investigation and/or correction if needed.

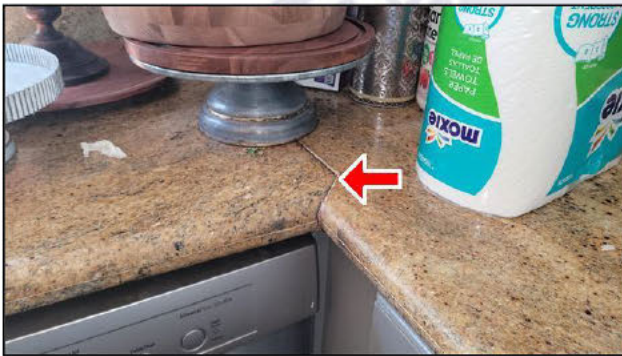
8.4 Item 8(Picture)

(4) Countertop is separated in kitchen. Repairs are needed. A qualified licensed professional should repair as necessary.

Countertop is missing end cap at a number of areas in kitchen. Repairs are needed. I recommend repair or replace as needed.

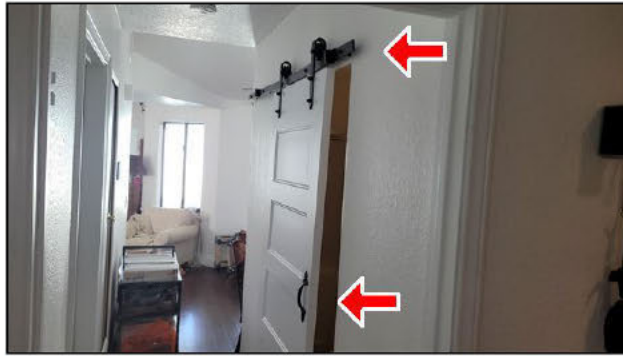
8.5 Item 1(Picture)

🔧 (1) The sliding door track is loose and will not close at the south hall bath. An adjustment/ repair is needed. A qualified person should repair or replace as needed.

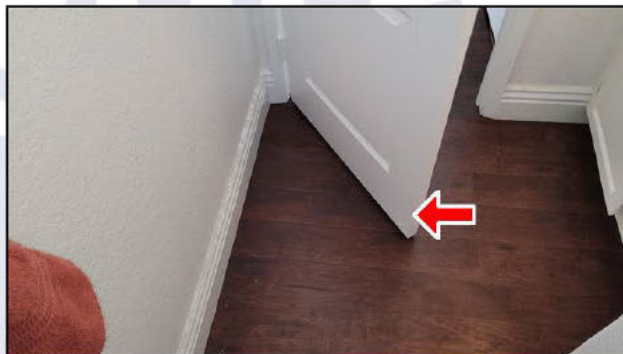
8.5 Item 3(Picture)

🔧 (3) Doorstops are missing/ damaged at a number of areas. Recommend repair or replace as necessary.

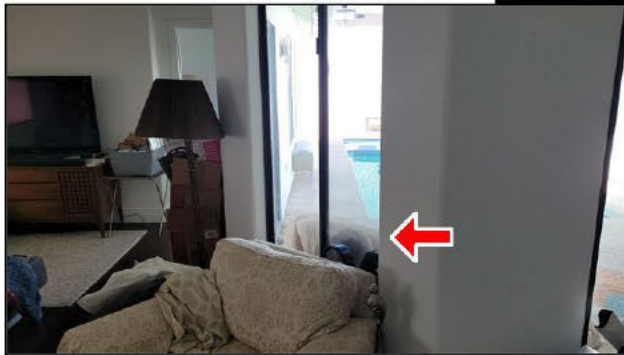
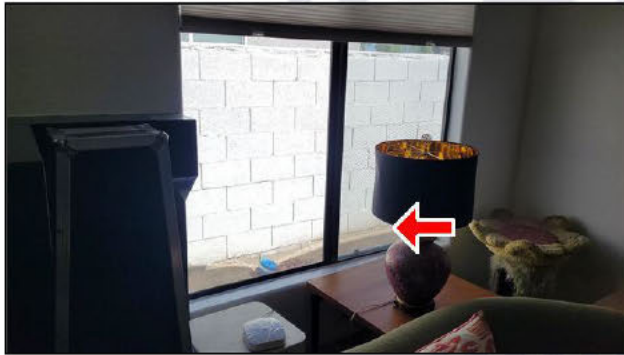
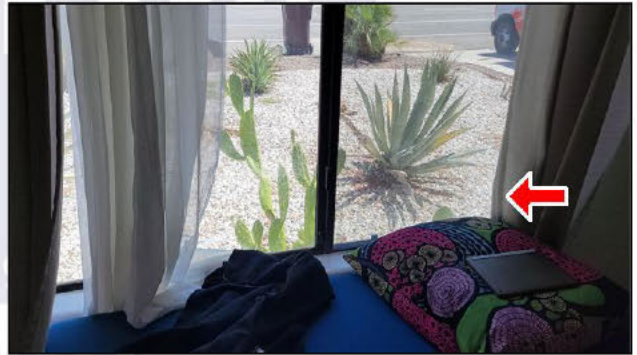
8.6 Item 2(Picture)

👉 (2) Several windows do not travel across tracks smoothly and may need rollers replaced at multiple locations. This is a maintenance issue and is for your information. I recommend correct as necessary.

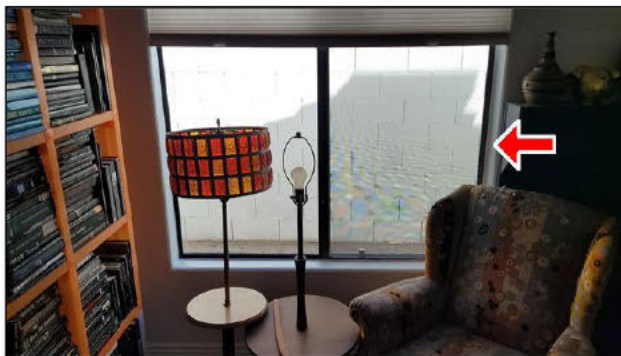
8.6 Item 7(Picture)

👉 (3) Two windows are stuck or painted shut at the rear Guest Bedroom and Living Room. A repair may be needed. I recommend correct as necessary.

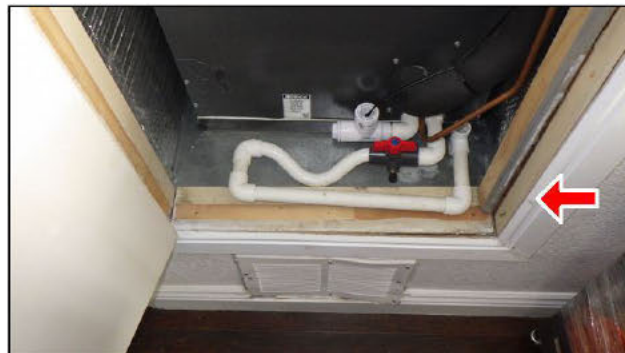
9.0 Item 1(Picture)

Return air plenum under air handler (s) was not accessible and could not be inspected.

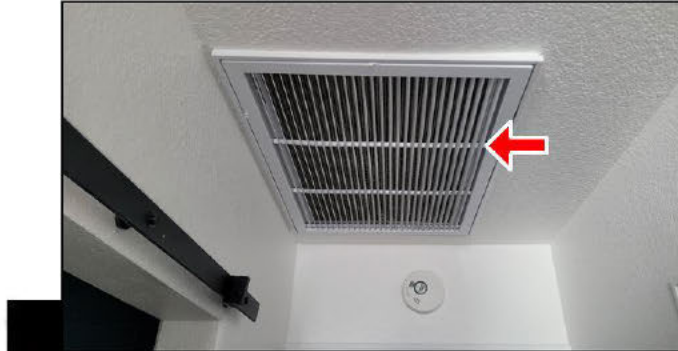
9.3 Item 1(Picture)

Filter location (see photo)

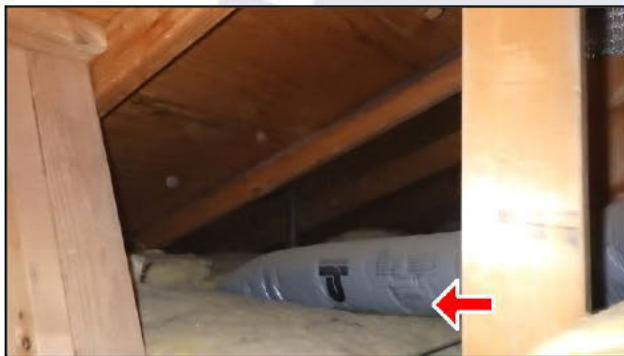
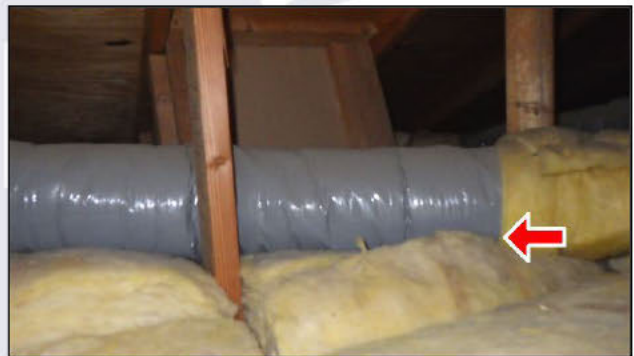
9.3 Item 2(Picture)

🔧 (2) The duct pipe should be supported above insulation to prevent condensation in the attic. While this may or may not have been required at time of construction, we recommend correction. I recommend correct as necessary.

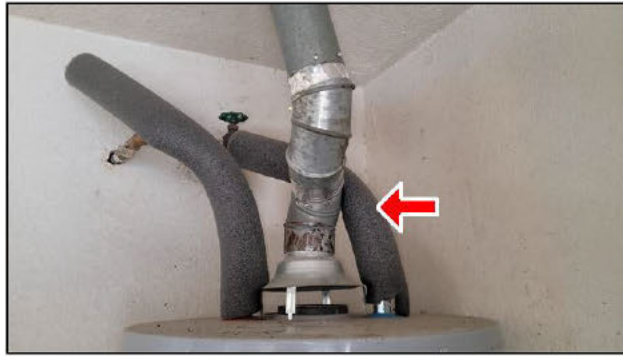
9.5 Item 1(Picture)

🔧 **+** The vent pipe for gas water heater is in contact with pipe insulation and should be re-routed to prevent damage. This is a safety issue and should be corrected. Recommend correct as necessary.

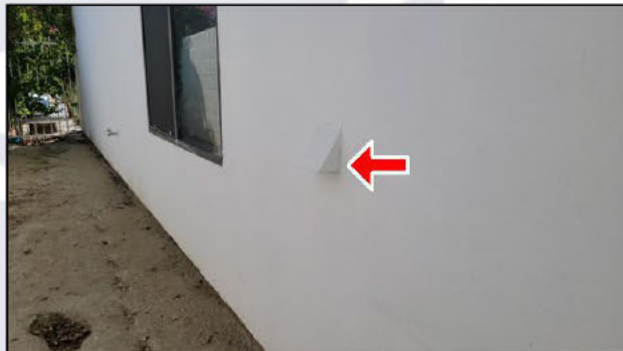
9.7 Item 1(Picture)

🔧 (2) Fireplace has an improper ventilation hood outside. Recommend correct as necessary with proper licensed specialist.

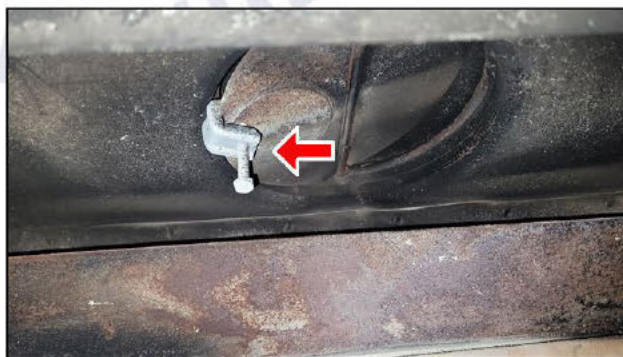
9.7 Item 2(Picture)

🔧 **+** (3) The damper for fireplace at the Living room has the damper spacer installed improperly. The damper spacer should be installed so damper is blocked fully open. Without a clamp to force open the damper fully, it could shut and cause unsafe carbon monoxide to enter into living space. A qualified person should repair or replace as needed.

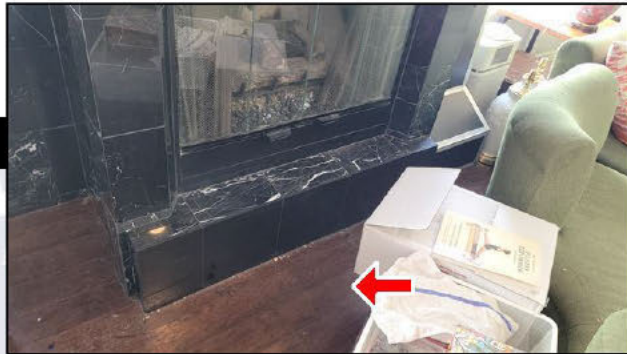
9.7 Item 4(Picture)

🔧 + (5) The Tile hearth extension for fireplace at the Living room has flammable items that may ignite when using fireplace and should be distinguishable (different) from surrounding floor covering. This area should be repaired to protect the integrity of the hearth. I recommend correct as necessary.

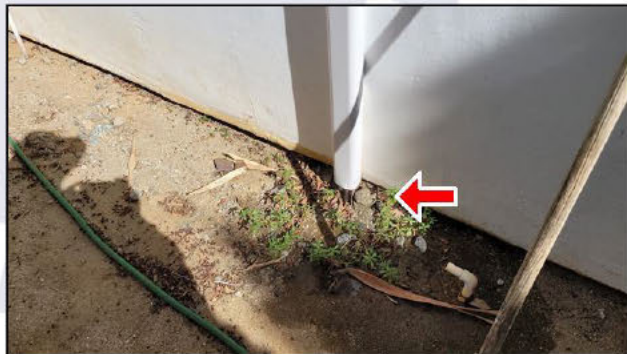
9.8 Item 1(Picture)

🔧 (1) The suction line is missing foam sleeve in area(s) at outside unit. Missing foam on suction line can cause energy loss and condensation. I recommend service or repair as needed.

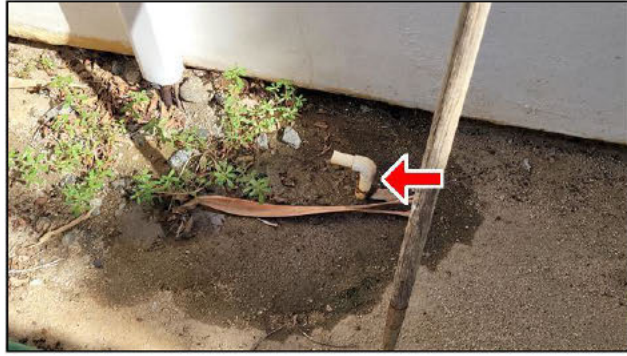
9.8 Item 2(Picture)

🐿 (2) Condensation line is missing an elbow at termination. Recommend correct as necessary.

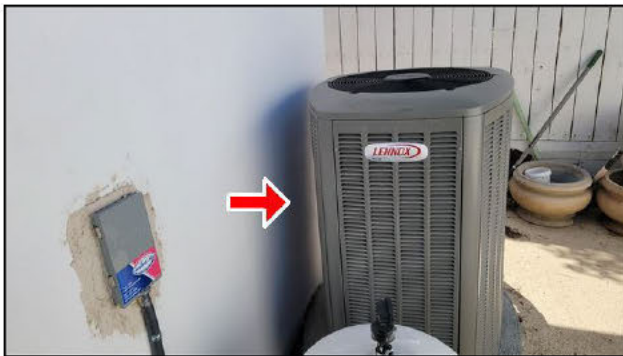
9.8 Item 3(Picture)

🐿 (3) The condenser does not have proper clearance for proper air flow. This may hinder the efficiency of the unit. I recommend correct as necessary.

An air conditioning condenser dissipates heat to the exterior air. There should be a 3-foot clearance at the air discharge and a 1-foot clearance where air enters the coil.

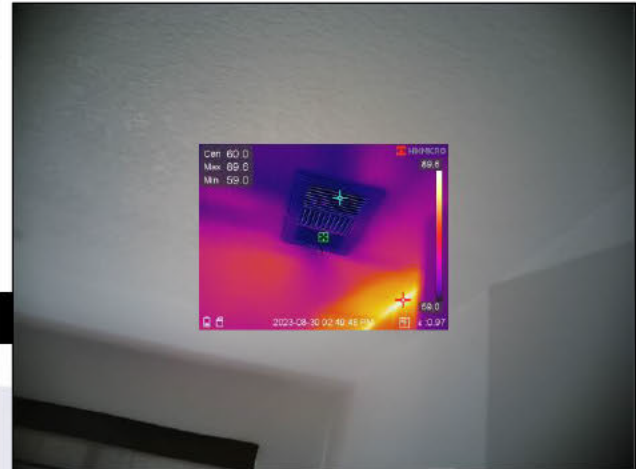
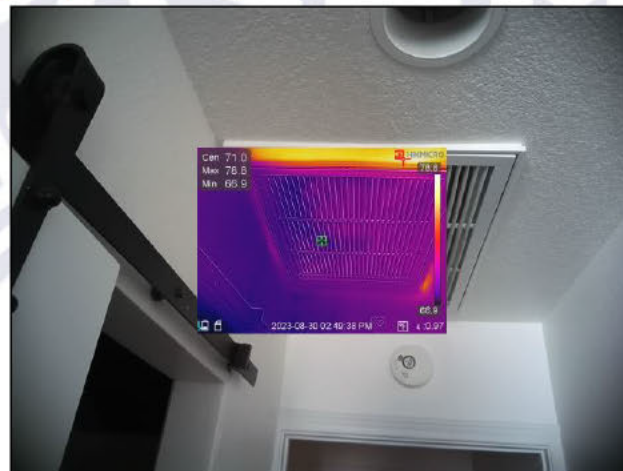
9.8 Item 5(Picture) Temperature drop

(4) The ambient air test was performed by using thermometers on the supply and return air registers of Heat pump in cool mode to determine if the difference in temperatures of the supply and return air are between 14 degrees and 22 degrees which indicates that the unit is cooling as intended. The supply air temperature on your system read 59 degrees, and the return air temperature was 71 degrees. This gives a temperature differential of 12 degrees which is inadequate. This indicates that the unit is **not cooling** properly and a licensed Heat/Air contractor should inspect for cause or problem.

While the unit operates, the temperature drop across the AC cooling coil is easily measured with a temperature gauge and long probe. The temperature drop should be between 14° and 22° Fahrenheit.

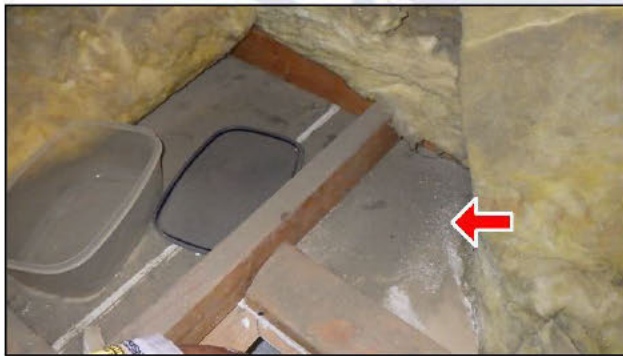
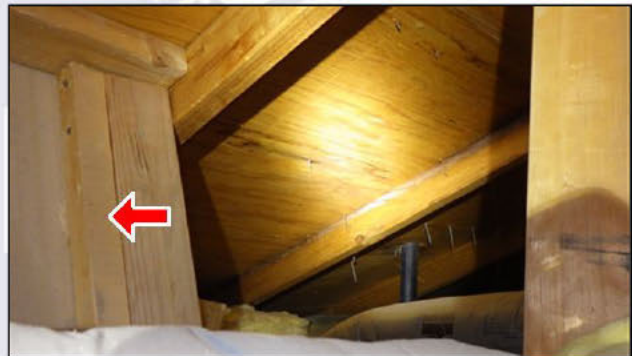
10.0 Item 1(Picture)

🔧 (1) Insulation is missing in areas in attic. Heating / Cooling loss can occur more on this home than one that is properly insulated. I recommend correct as necessary.

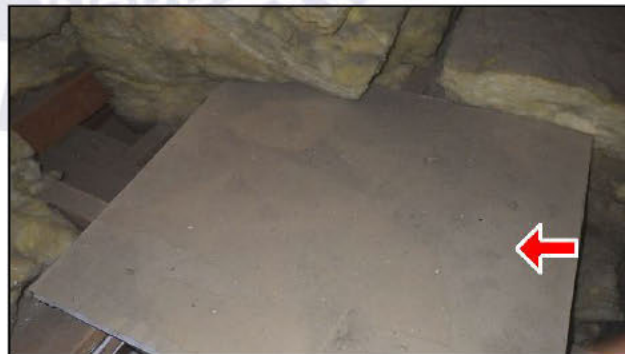
10.0 Item 3(Picture)

🔧 (2) Attic access cover is missing insulation and needs correction. While this may be a newer requirement, we recommend upgrading for energy efficiency.
